# Belleville North Solar Project Water Body Site Investigation Report

Belleville North Solar Project

H334844-0000-07-124-0017

August 15, 2011

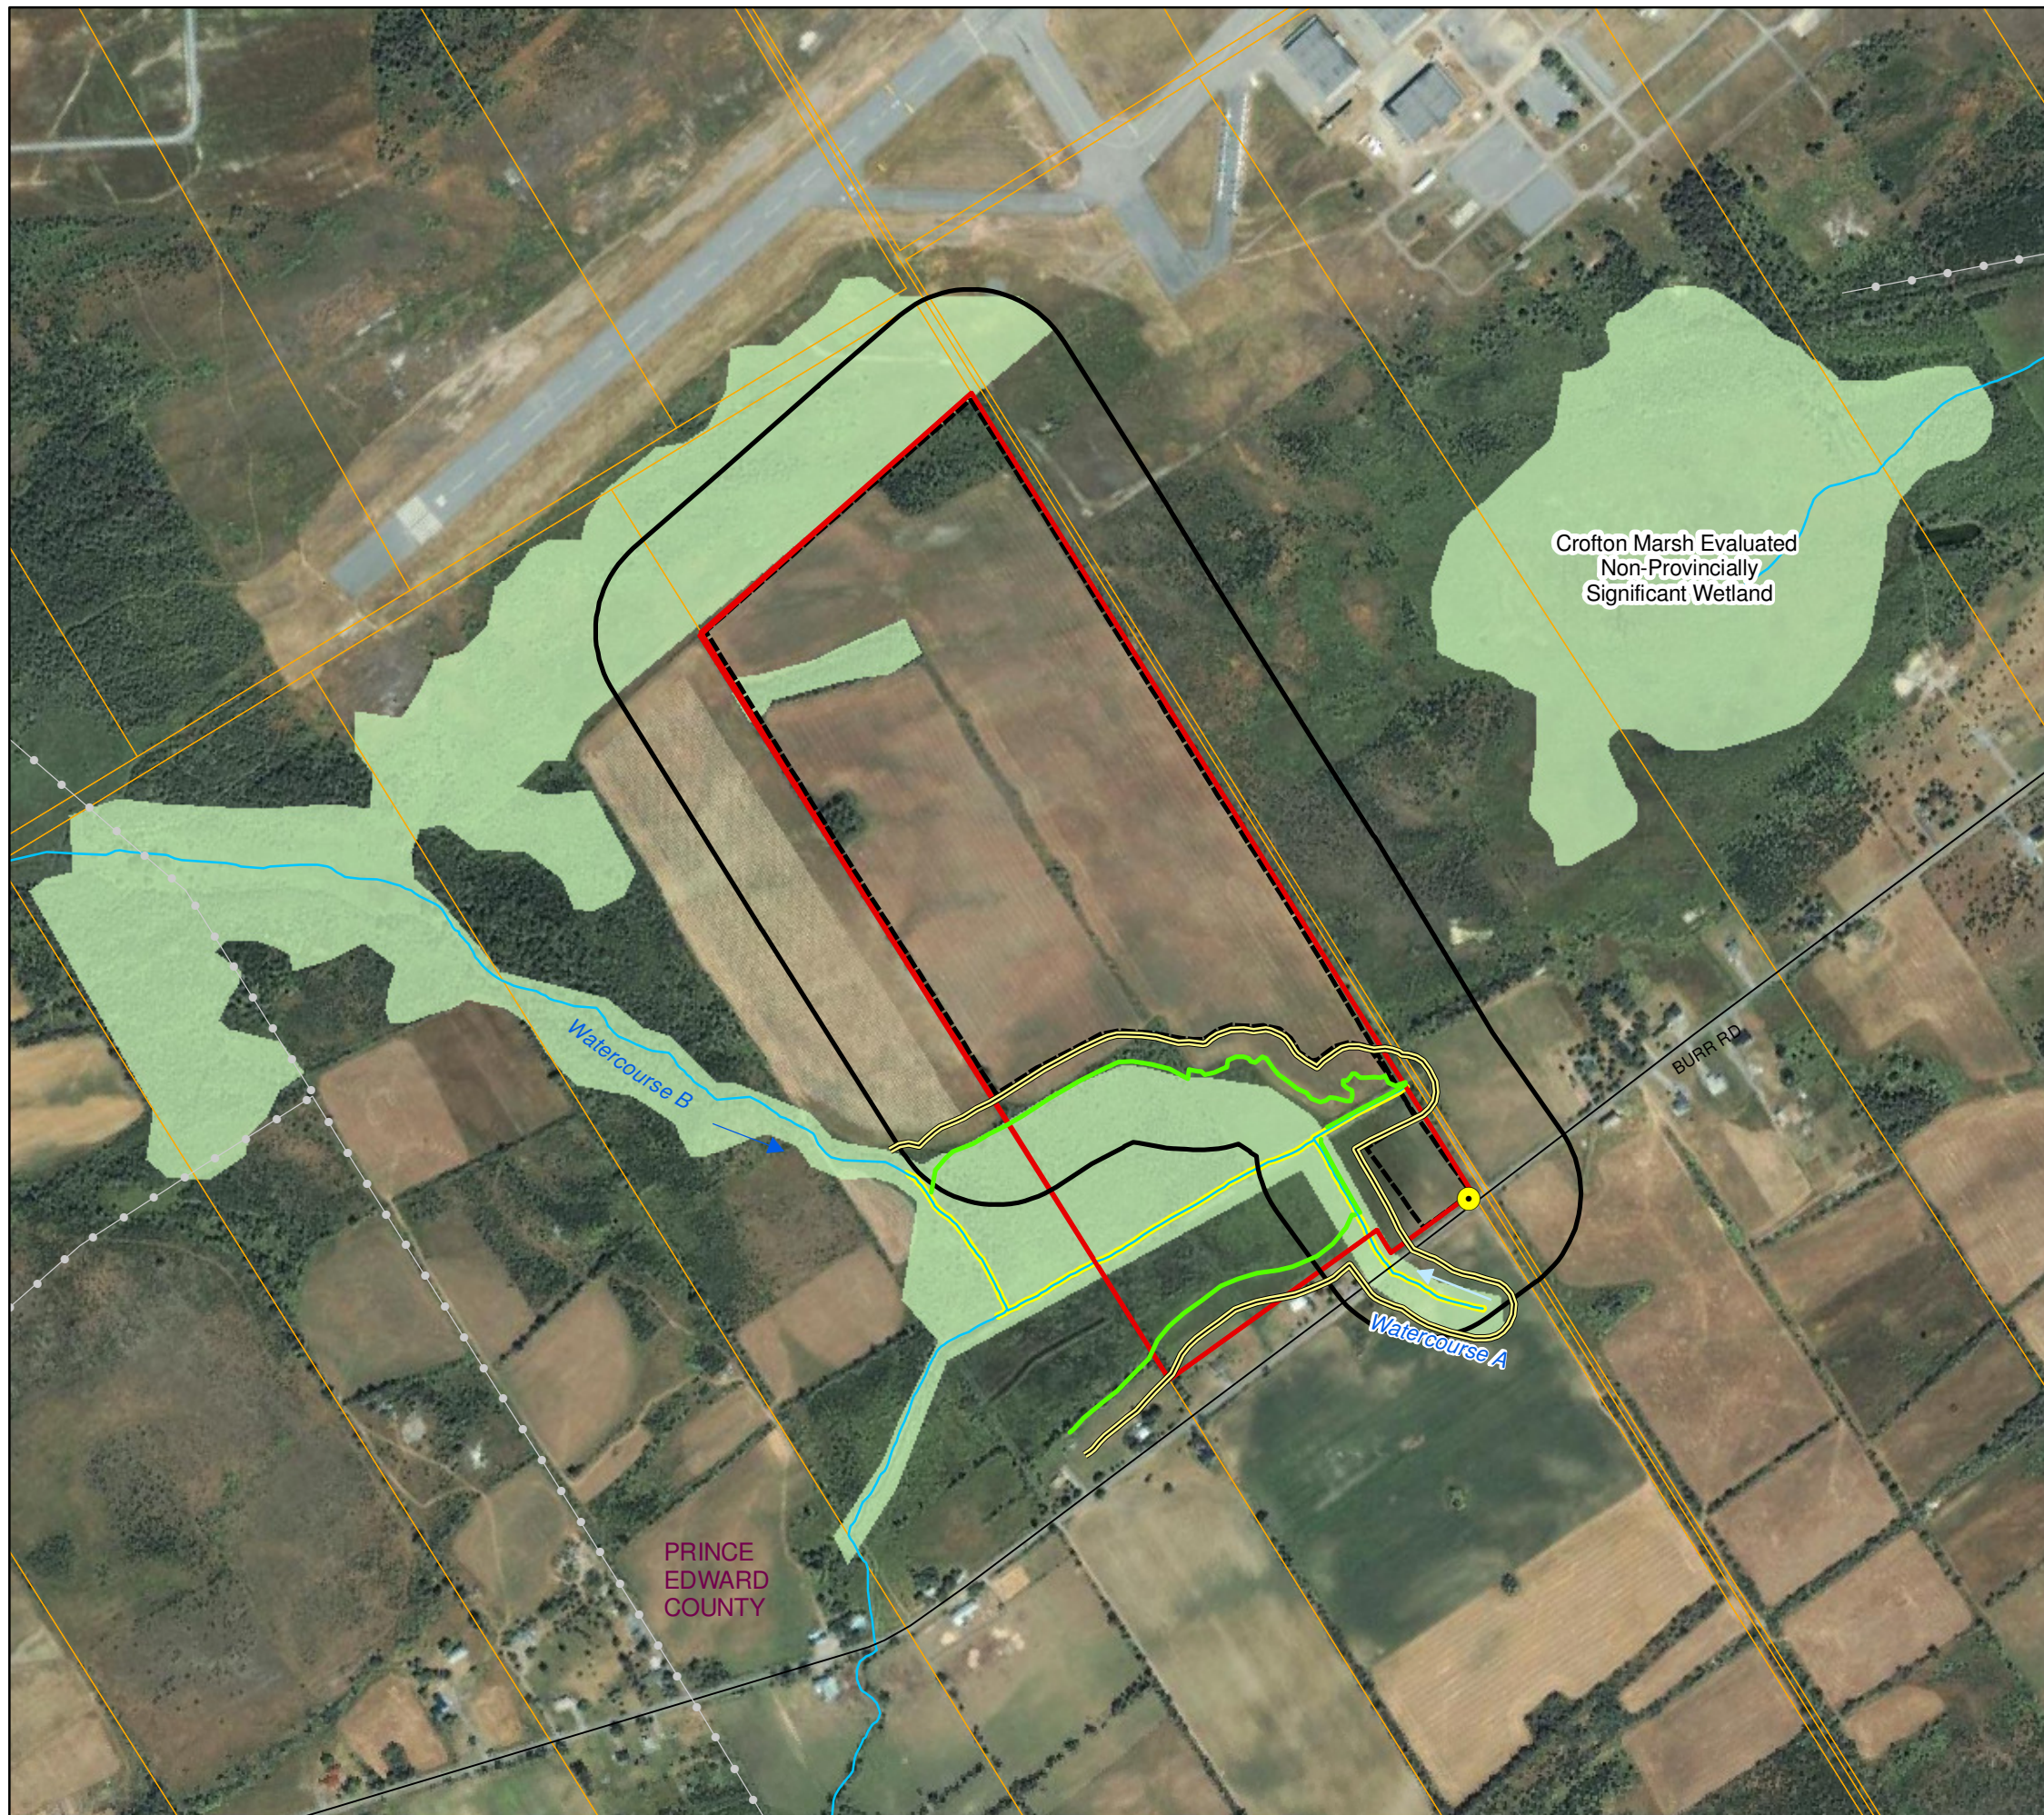
Figure 4.1  
 Northland Power Inc.  
**Belleville North Solar Project**  
**Water Body and Project Boundaries**

This section documents the results of the Site Investigation and discusses specific water features observed on and adjacent to the subject property. Features noted in the following sections, including the Project footprint boundary and the average annual high water mark and 30-m setback areas associated with watercourses are shown in Figure 4.1.

As shown in Figure 4.1, the Project footprint boundary is greater than 30 m from the average annual high water mark, but in some areas, it is less than 120 m. In addition, the proposed distribution line from the substation and a new facility access road will cross the unnamed excavated drain on the Project site. Therefore, an EIS will be required to assess the potential for adverse effects and mitigation measures required to prevent/minimize these adverse effects.

The site investigation has confirmed that Watercourse B is likely a permanent watercourse. The average annual high water mark, based on top of bank features and riparian vegetation communities is shown in Figure 4.1. The Project footprint boundary will be located approximately 120 m from the a small portion of the average annual high water mark of Watercourse B, near its mouth at Watercourse A. Therefore, the EIS will be required to assess the potential for adverse effects and mitigation measures required to prevent/minimize these adverse effects.

The REA Regulation requires that all solar panels and inverters be set back at least 30 m from the boundary of the seepage area. This boundary, the 30-m setback and the potential development area are shown in Figure 4.1.

Based on the results of the site investigation and the proposed Project footprint shown in Figure 4.1, some components of the facility will be located between 30 and 120 m of Watercourse A and the seepage area in the wetland. In addition, the proposed new distribution line and a new facility access road will cross an excavated drain on the Project site. Therefore, an Environmental Impact Study (EIS) will be required.

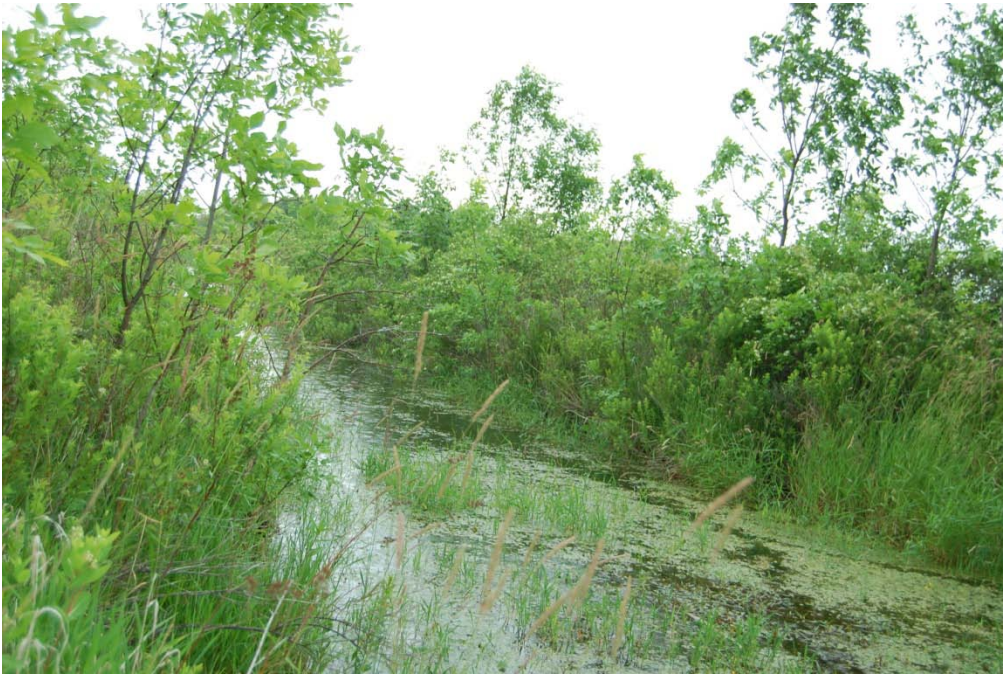
**Figure 4.2 Watercourse A on the Project Site**

Watercourse A is approximately 4 to 5 m wide and <0.60 m deep in most locations and is characterized as low-gradient and slow-moving. Emergent, submergent and floating leaved vegetation was present throughout the channel on the Project site. Substrate was primarily fine muck, comprised of organic and mineral material. Riparian zones are dominated by grasses and shrubs and there is overhanging vegetation along the length of the channel.

Where Watercourse A runs along the southern Project boundary in a westerly direction, it runs through a meadow marsh and swamp thicket wetland, which appears to be fed by groundwater discharge. Vegetation within the wetland community included various grasses, sedges, rushes and forbs, as well as shrubs such as willows and dogwoods.

A photograph of Watercourse A where it runs through the Project site is shown in Figure 4.2.

The site investigation has confirmed that Watercourse A is a permanent stream. To establish the average annual high water mark (as per the REA requirement), (i) riparian vegetation was assessed to establish the boundary of vegetation species tolerant of annual flooding, (ii) valley and topographic features such as the top of bank were observed. Based on these observations made during the site investigation, the high water mark along Watercourse A is based on the top of bank feature, although, as discussed in Section 4.1.3, the adjacent wetland has been identified as a seepage area, which also requires a 30-m setback.

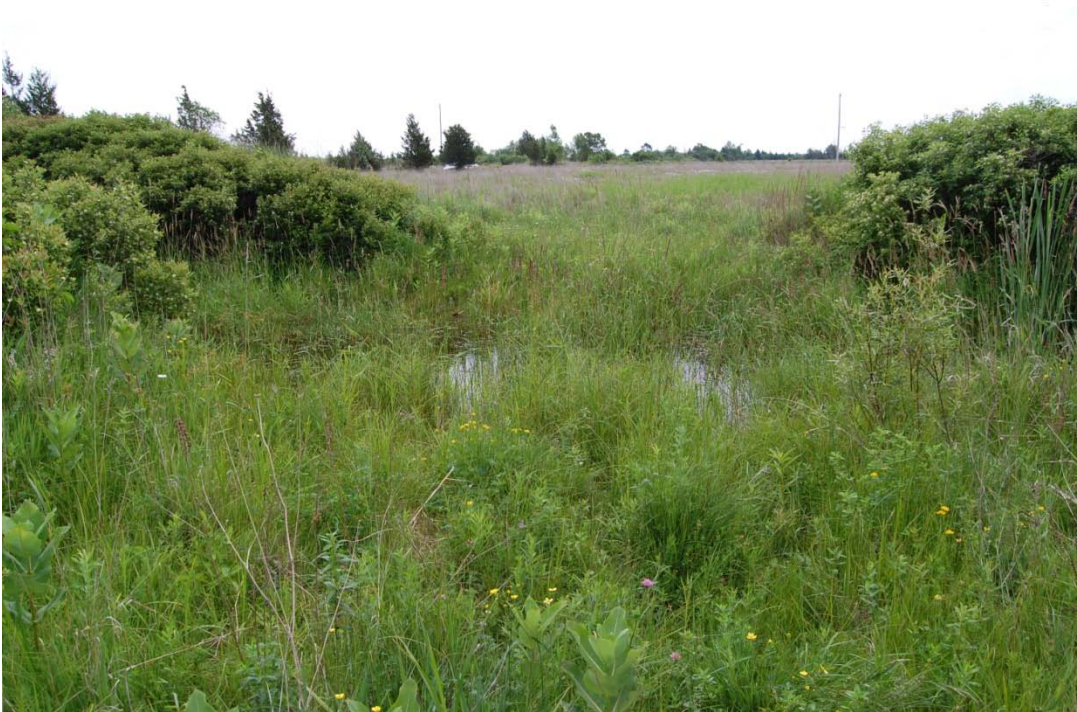
**Figure 4.3 Seepage Area in Wetland**

The Quinte Conservation Authority Groundwater Study (2009) identified the Project area as a potential groundwater discharge zone. The site investigation confirmed that the wetland at the south end of the Project site noted during the Records Review exhibits indicators of groundwater discharge, including wetland vegetation requiring continuously moist soil conditions and presence of a high groundwater table. The groundwater table appears to intersect the land surface, with groundwater ultimately discharging to Watercourse A.

The wetland is approximately 350 m wide by 375 m long. Vegetation communities are dominated by meadow marsh and shrub thicket vegetation. Common meadow species include various grasses [e.g., Canada blue-joint (*Calamagrostis canadensis*)], sedges and rushes, as well as blue flag (*iris versicolor*), cattail (*Typha sp.*) and mixed upland meadow species including milkweed (*Asclepias syriaca*) and red clover (*trifolium pretense*). Shrubs include various willows (*Salix sp.*) and dogwoods (*Cornus sp.*).

A photograph of the wetland area is provided in Figure 4.3.
