Burk's Falls East Solar Project

Draft Water Body Site Investigation Report

H334844-0000-07-124-0161
Rev. D
February 25, 2011

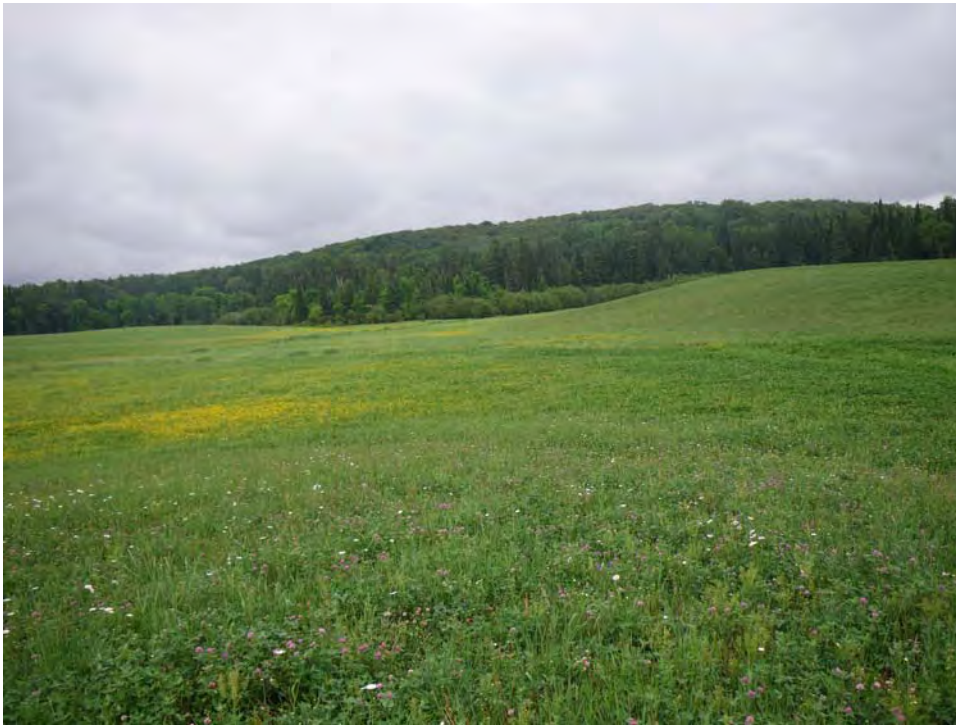
The northern half of the Project location is comprised primarily of agricultural lands and is described as an active livestock (i.e., cattle) operation. The majority of the agricultural fields are used as cattle pasture. There are several woodlands located within 120 m of the Project location. Three of these woodlands extend onto the agricultural fields, along the eastern boundaries and southern portion of the Project location. In addition to woodlands, there is a wetland that follows the length of a tributary of the Magnetawan River which flows east to west south of the Project location. A photograph of the agricultural fields on the Project location is shown in Figure 4.1.

Figure 4.1 South Facing View of the Agricultural Fields and Woodlands on the Project Location

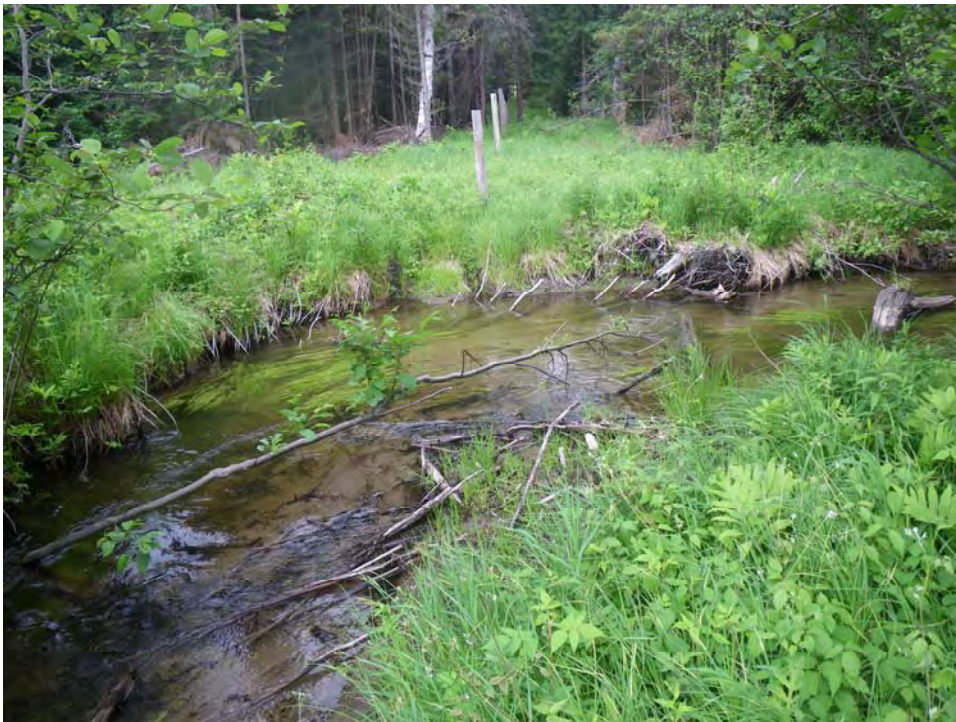
Tributary A runs in an east to west direction within 120 m south of the Project location. The watercourse was flowing during the site investigation and appears to be a permanent watercourse, given its size. The watercourse was primarily a moderate velocity run, with some slower moving

sections in deeper and or wider reaches and scattered areas of slightly higher flow velocity in more laterally constrained sections of the channel or in areas where debris has created constrictions to flow. Average width was approximately 2 to 3 m and average water depth was less than 0.30 m at the time of the site investigation. Substrate consists of a mix of loamy sand, sandy loam and poorly drained muck (decomposed organic material) soils with scattered organic debris (e.g., leaves, sticks, logs) observed throughout the watercourse. There were several small beaver (*Castor canadensis*) dams observed within the portion of the stream that flows south of the Project location. There was no submergent aquatic vegetation; however, patches of filamentous algae were observed.

The stream meanders through a low-lying, relatively open meadow marsh, bordered by some shrub thicket and surrounding forests. The immediate banks of the watercourse are well vegetated, with some overhanging grasses and sedges. Evidence of erosion and undercutting to the stream bank was observed along portions of the watercourse. During periods of high flow, the watercourse likely inundates the adjacent low-lying meadows, which consist primarily of grasses and sedges.

Figure 4.2 Photograph of Tributary A South of the Project Location

Based on the observations made during the site investigation, Tributary A appears to be a permanent watercourse capable of providing habitat for a coldwater fish community, comprised of salmonids such as brook trout (*Salvelinus fontinalis*) and common associates such as mottled sculpin (*Cottus bairdi*). Abundant fish cover habitat is available among the woody debris, around the overhanging grasses and undercut banks. No spawning habitat for brook trout was observed, but this may be present in higher gradient reaches farther upstream if gravel is present. Water quality in Tributary A is likely good, being moderated by relatively wide and heavily vegetated riparian buffers, with groundwater inputs observed in several locations.

The average annual high water mark was assessed during the site investigation and was found to be the limit of wet meadow vegetation adjacent to the tributary channel. The surrounding vegetation is dominated by grasses, sedges and rushes which provides evidence of annual flooding during higher flow events. The average annual high water mark, associated 30-m setback limit and the proposed solar panel footprint boundary are shown in Figure 1.1. The proposed development footprint will be located between 30 and 120 m from Tributary A; therefore, an environmental impact study (EIS) will be required.

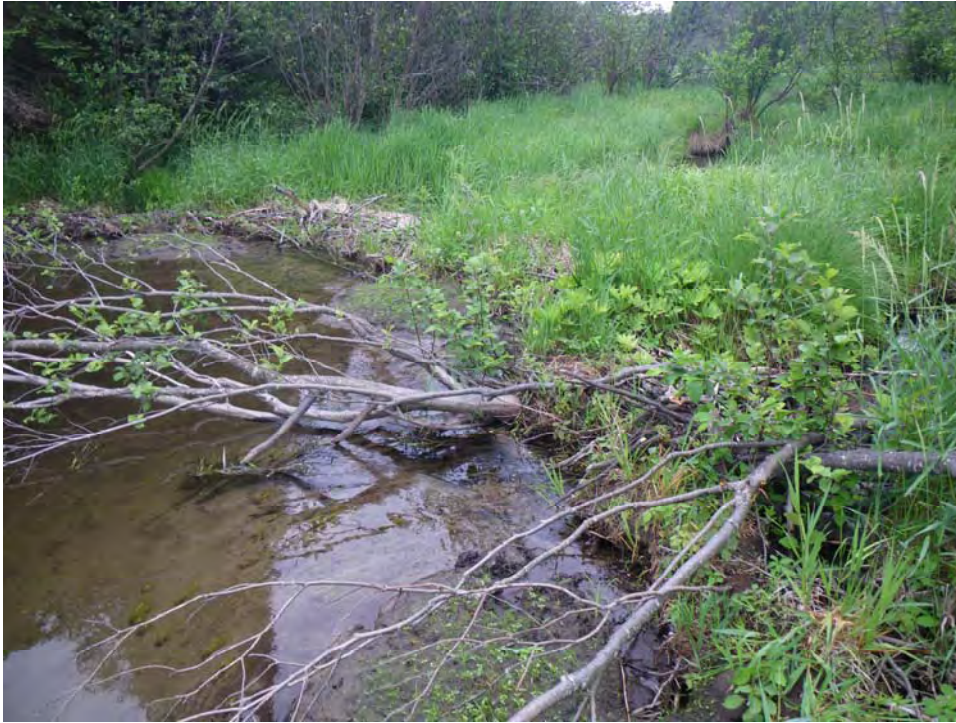
Photographs of typical aquatic and riparian habitat conditions in Tributary A are provided in Figures 4.2 and 4.3.

Figure 4.3 Photograph of a Beaver Dam Across Tributary A South of the Project Location

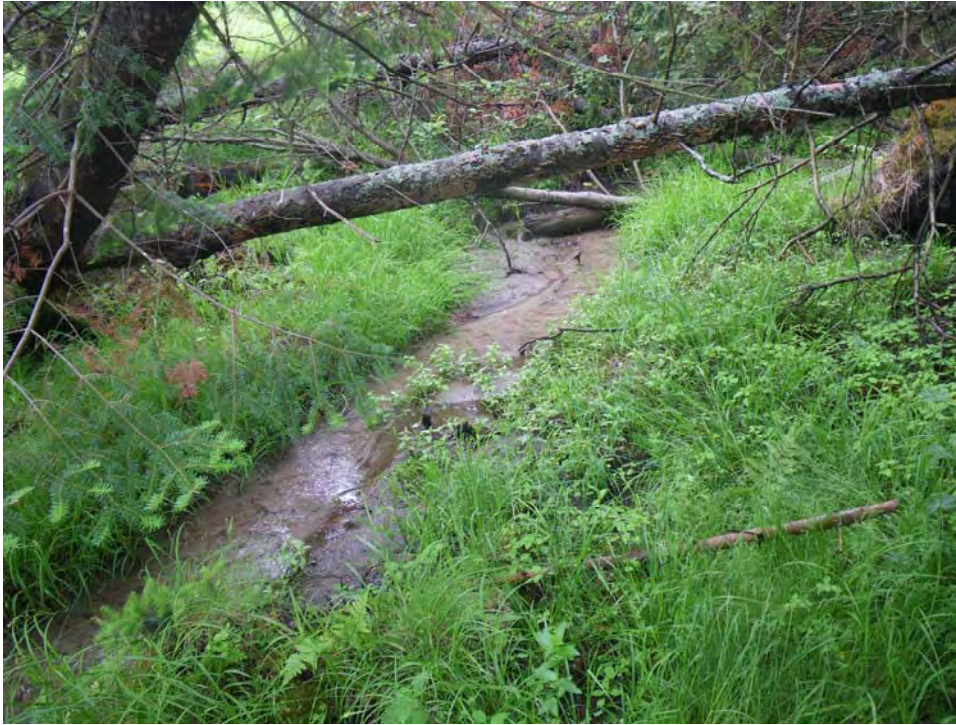
The channel within the woodland at the upstream end of Tributary C is well defined and consists of an approximately 1 m wide, shallow channel, dominated by sand and muck substrate, with organic debris observed at the surface. There was a low amount of flow in the channel during the site investigation, but it appears to be intermittent in this section. Overhanging woody debris is relatively abundant within and adjacent to the channel. The bank full depth is approximately 0.15 m. Riparian vegetation within the woodland consisted of white spruce (*Picea glauca*), eastern white cedar (*Thuja occidentalis*), eastern hemlock (*Tsuga canadensis*), balsam fir (*Abies balsamea*) and speckled alder (*Alnus incana*). Groundcover vegetation was dominated by jewelweed (*Impatiens capensis*), sensitive fern (*Onoclea sensibilis*), grasses and sedges. A photograph of typical habitat conditions within this section of Tributary C is provided in Figure 4.4.

Figure 4.4 Portion of Tributary C Within the Woodlot on the Property

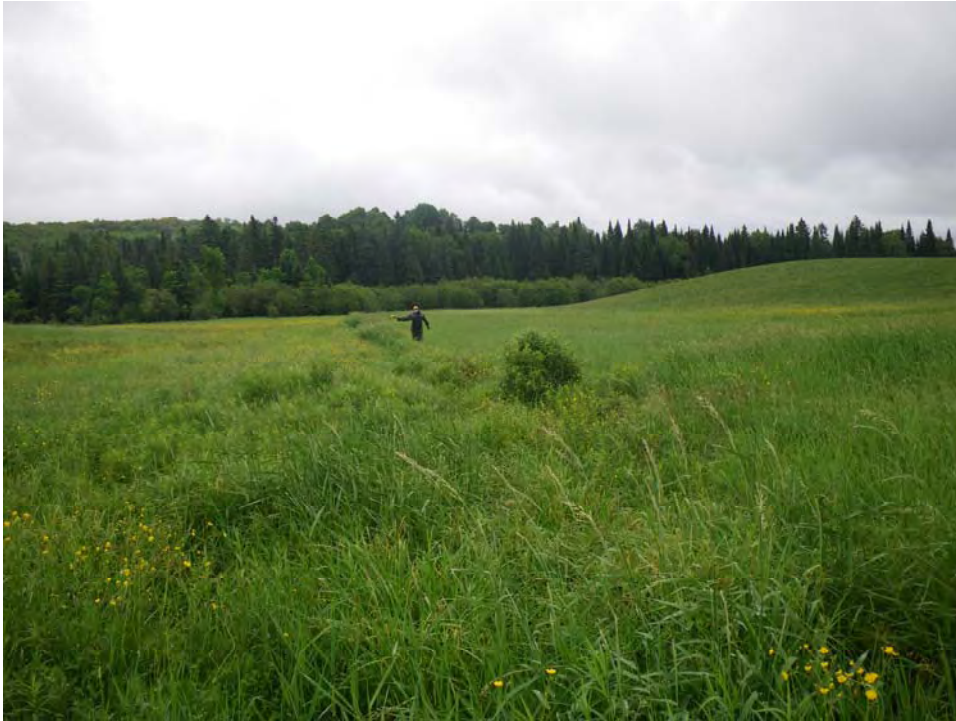
The streambank consists of relatively dense meadow vegetation, including common cattail (*Typha latifolia*), small fruited bulrush (*Scirpus microcarpus*), soft rush (*Juncus effuses*) and a variety of sedges, grasses, ferns and forbs tolerant of annual inundation and wet soil conditions. The community transitions into the adjacent upland meadow species. More detailed information the vegetation community in the area can be found in the Natural Heritage Site Investigation Report (Hatch Ltd., 2010b). A photograph of Tributary C and adjacent riparian areas is provided in Figure 4.5.

Figure 4.5 Tributary C and Adjacent Riparian Areas – View South From Edge of Woodlot

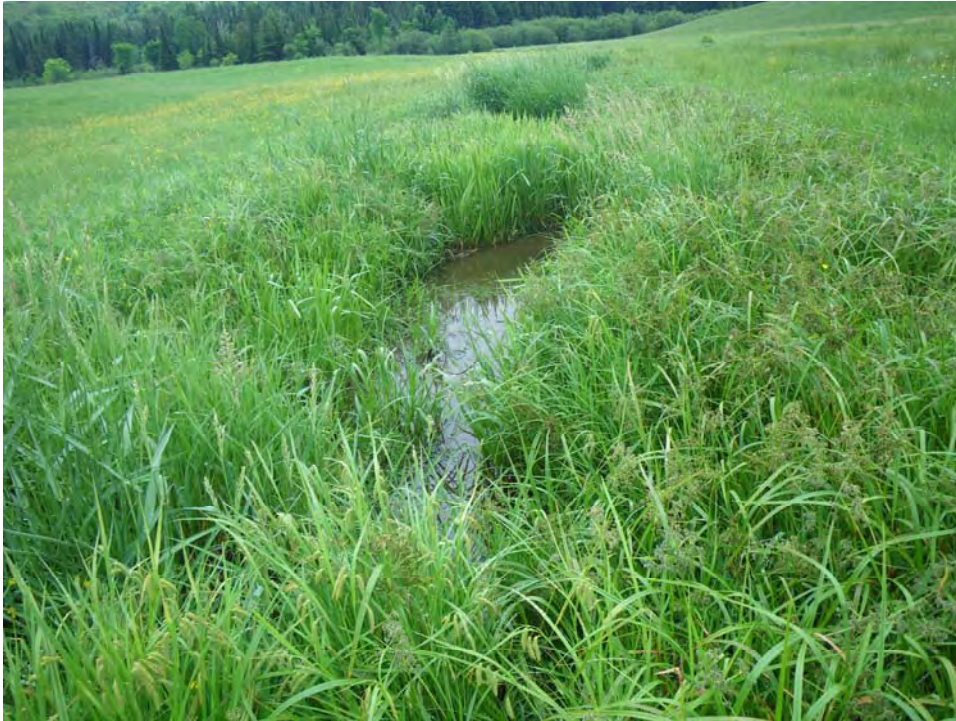
A view of the channel itself is provided in Figure 4.6. A number of small baitfish were observed within the section of channel immediately upstream from the edge of the shrub thicket that Tributary C flows into. Tributary A is located approximately 40 m farther downstream.

This section of Tributary C may be permanent and appears to provide aquatic habitat for some fish and benthic invertebrate species. It may provide additional habitat on a seasonal basis during higher flow periods, for fish moving upstream from Tributary A. Tributary C also serves to maintain baseflow and water temperature in farther downstream reaches due to the observed groundwater input, while also regulating hydrology and water quality by buffering surface water runoff from the adjacent fields.

Figure 4.6 Tributary C Channel Within Agricultural Field Portion of Property

The average annual high water mark was assessed as the limit of low-lying wet meadow type vegetation in the watercourse area. Figure 1.1 shows the watercourse, the average annual high water mark and associated 30-m setback, and the proposed development footprint. Since the proposed development will be located between 30 and 120 m from the tributary, an EIS will be required. In addition, upgrading of the existing water crossing and installation of an electrical connection over the tributary will also be required, which also necessitate the need for an EIS.

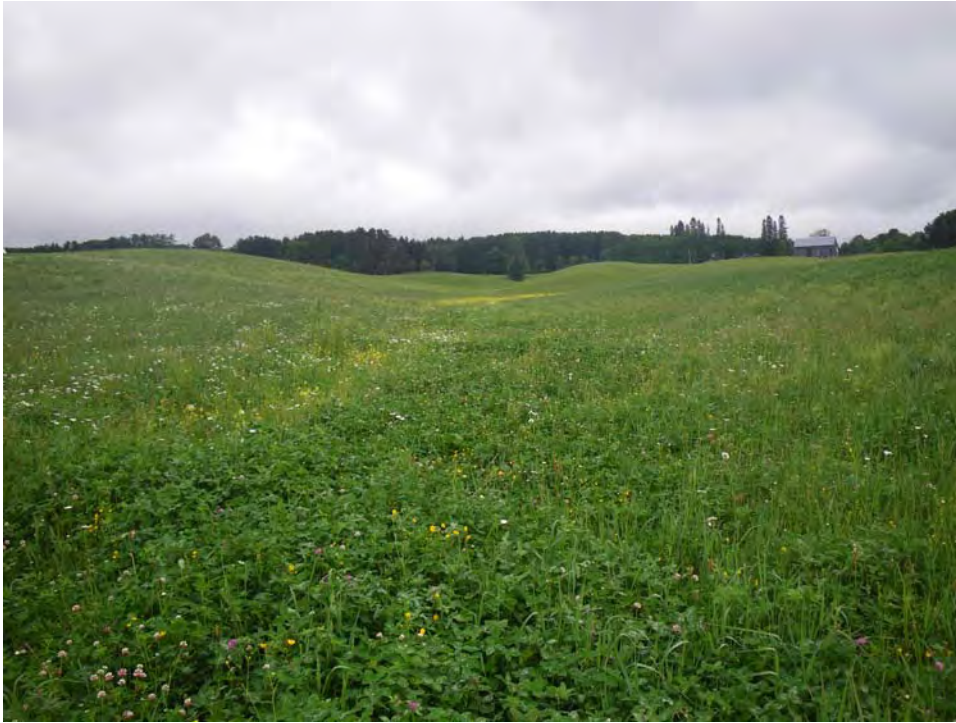
The portion of Tributary E that is identified as a grassed waterway does not have a defined channel and vegetation within the area is not consistent with species that require or prefer submerged or continuously saturated soil conditions. It is dominated by upland meadow vegetation such as red clover (*Trifolium pratense*), tall buttercup (*Ranunculus acris*), ox-eye daisy (*Chrysanthemum leucanthemum*) and birdsfoot trefoil (*Lotus corniculatus*) as well as a variety of grass species. This portion of the tributary is identified as a grassed waterway given that surface drainage is likely conveyed through this channel through natural processes associated with the sloping topography. As a result of these findings, no setbacks are required around this portion of Tributary E and no EIS is necessary. A photograph along the mapped route of Tributary E is provided in Figure 4.7.

Figure 4.7 View North Along Location of Tributary E Noted During Records Review

The average annual high water mark was assessed as the limit of low-lying wet meadow type vegetation in the watercourse area. Figure 1.1 shows the watercourse, the average annual high water mark and associated 30-m setback, and the proposed development footprint. Since the proposed development will be located between 30 and 120 m from the tributary, an EIS will be required.

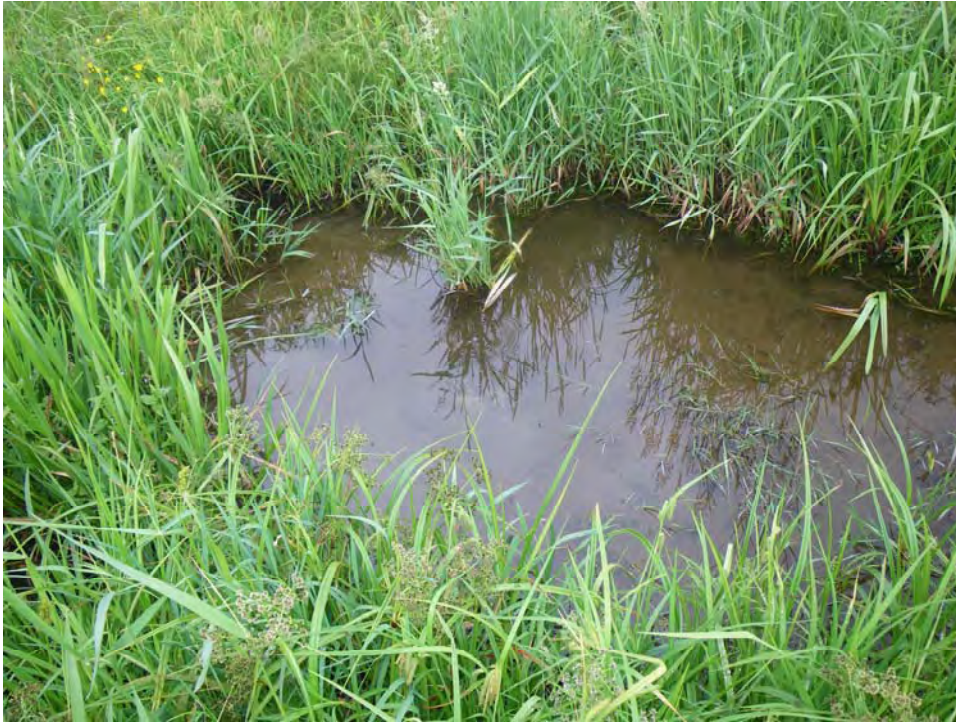
Seepage Area 1 is located approximately midway along Tributary C. The seepage area consists of groundwater bubbling up from the muck and sand channel bed. This seepage area likely provides baseflow and creates cooler water temperatures in Tributary C and the downstream reaches of Tributary A. This would assist in creating conditions conducive to a coldwater fish community of Tributary A. A photograph of the seepage area is provided in Figure 4.8.

Figure 4.8 View of Groundwater Seepage Area on Tributary C

Groundwater seepage areas are identified as waterbodies in the REA Regulation. Since the groundwater seepage area on Tributary C and the seepage area on the eastern end of Tributary A are located between 30 and 120 m from the proposed development, the EIS will have to assess potential effects and mitigation for this feature. The second seepage area into the south side of Tributary A is located > 120 m from the proposed development and will not be affected.

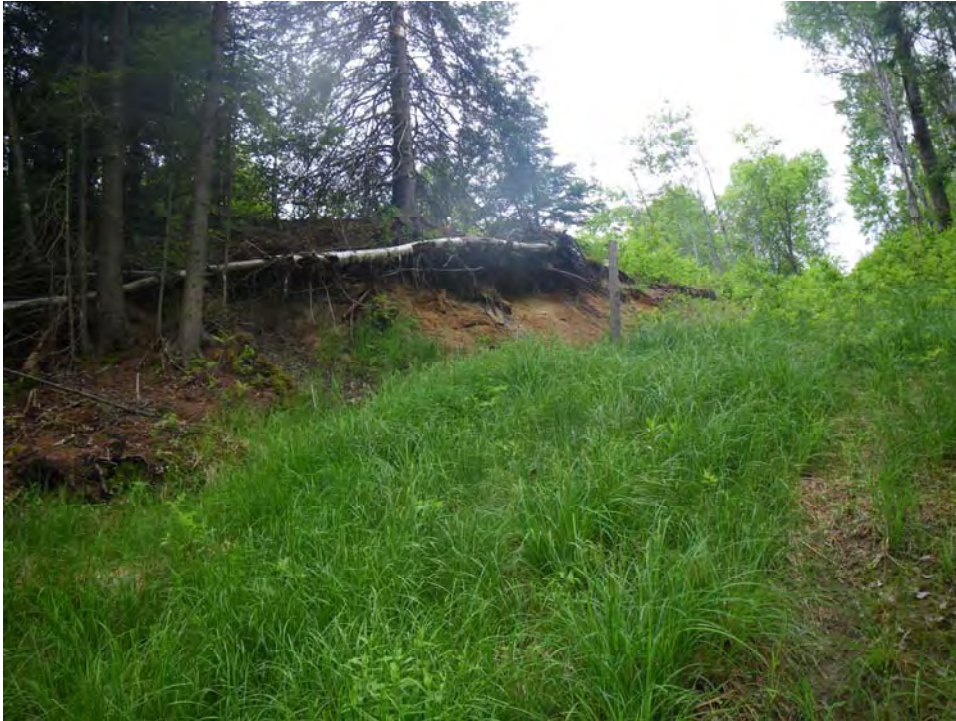
A second seepage area was observed approximately 60 m south of Tributary A. It consists of groundwater emerging as diffuse flow on the upper slopes of the watercourse valley. The groundwater runs down the valley toward Tributary A. Evidence of the seepage area included the presence of saturated soils, small patches of pooled water and meadow vegetation tolerant of such conditions. This seepage area may provide some baseflow and moderate water temperatures in Tributary A. A photograph of this area is provided in Figure 4.9.

Figure 4.9 View of Groundwater Seepage Area on Slope Adjacent to Tributary A
