Burk's Falls West Solar Project

Draft Water Body Site Investigation Report

September 7, 2011

H334844-0000-07-124-0185

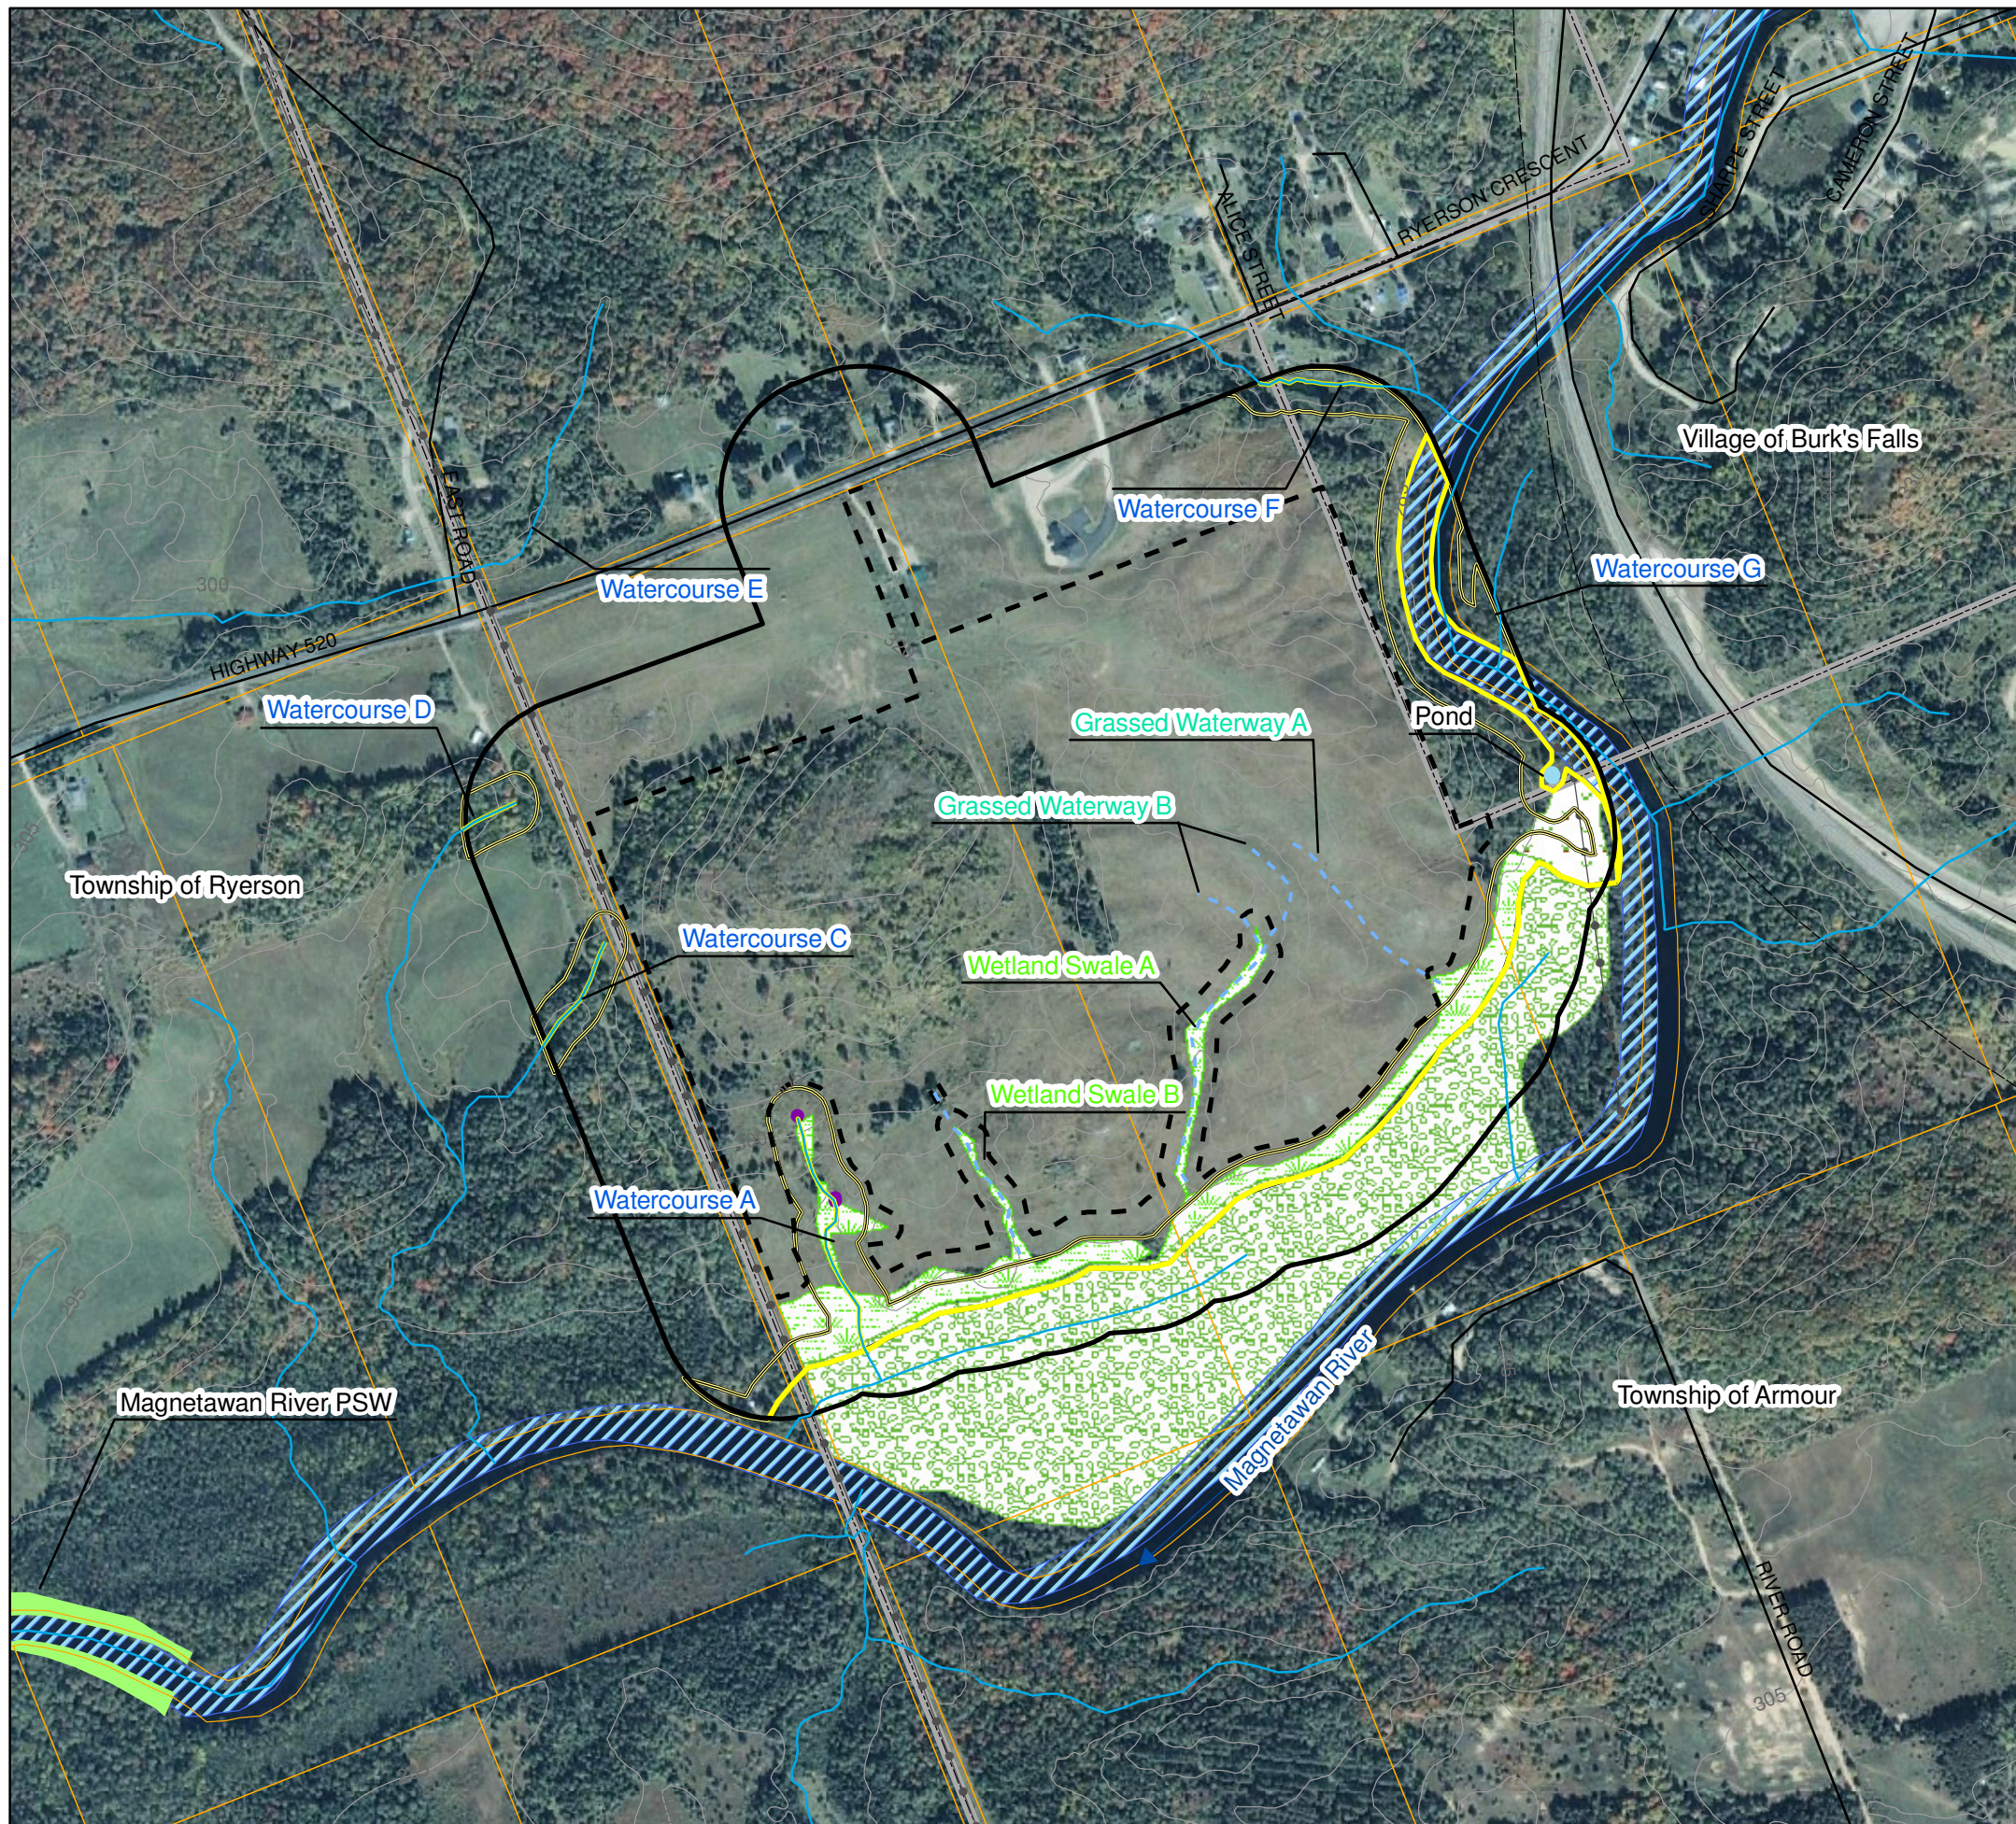
1:7,000 Figure 1.1
Northland Power Inc.

This section documents the results of the site investigation and discusses specific water features observed on and adjacent to the Project site. Features noted in the following sections, including the proposed Project footprint boundary and the average annual high water mark of watercourses and location of seepage areas on and within 120 m of the Project location, are shown in Figure 1.1.

During the site investigation, several additional drainage features not noted during the Records Review were observed. These are labelled as Watercourse A and Wetland Swale B in Figure 1.1 of this Report, and discussed in Section 4.1.3.

As shown in Figure 1.1, the average annual high water mark is located between 30 and 120 m from the Project location. Therefore, the potential adverse effects of the Project on the Magnetawan River and surrounding land will be assessed in the EIS.

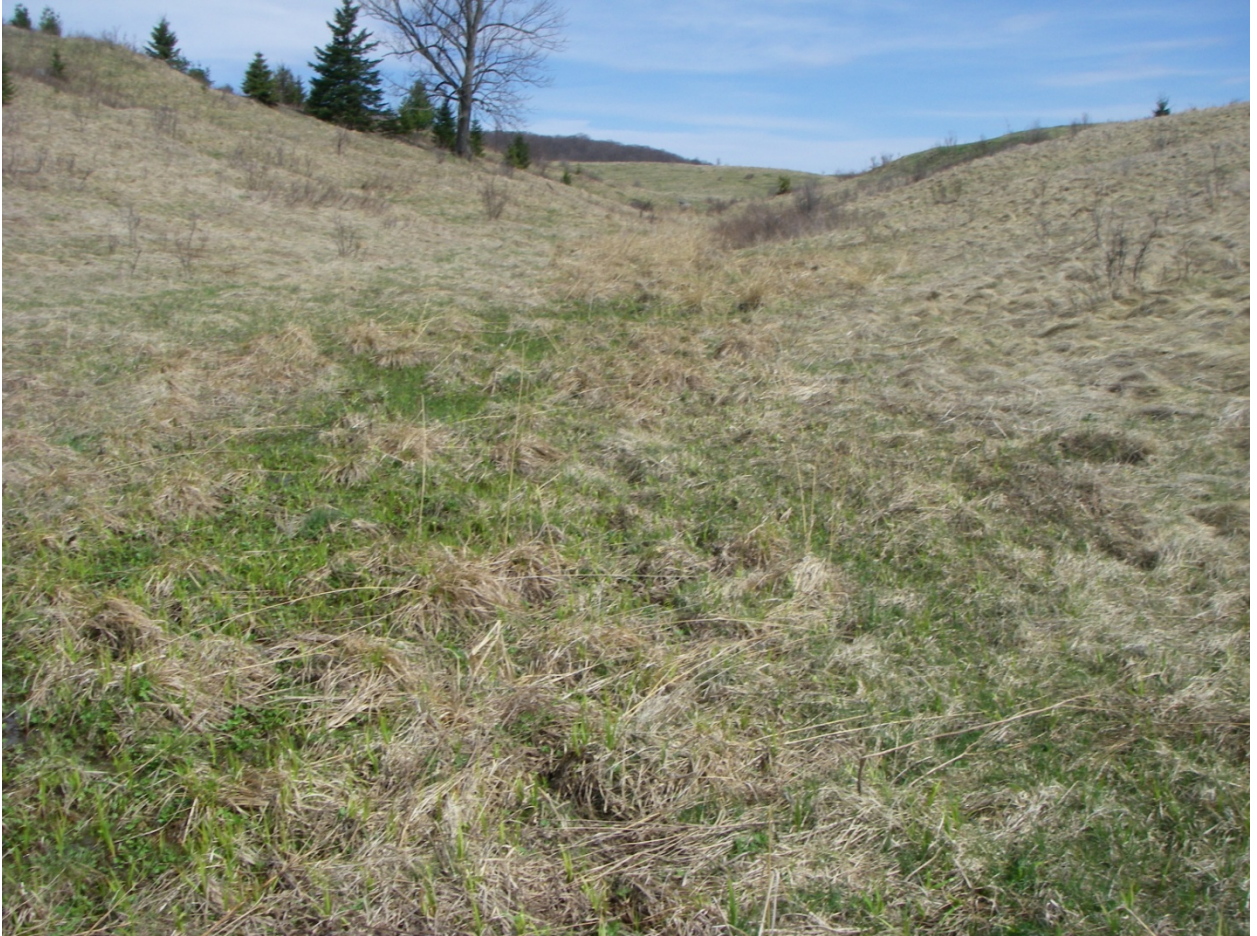
Figure 4.1 Photograph of Wetland Swale A Looking Up-gradient to Grassed Waterway B

During the site investigation, it was determined that this feature is a temporary drainage route consisting of a low lying area between adjacent rolling topographical features. There is no defined channel and there was no flow observed during the site investigation noted in Section 3, nor during any of the other site investigations conducted to assess natural heritage features of the property (as discussed in Hatch Ltd., 2011b). The upper reach of this swale contains a mix of primarily upland meadow vegetation. This reach is denoted as Grassed Waterway B in Figure 1.1. The low lying area down gradient predominantly consists of mineral meadow marsh vegetation, with sedges (primarily green, beaked, awl fruited and small fruited sedges) dominating the vegetation community. Horsetails, golden rods, and Canada blue-joint was also present although primarily on the peripheries or any slightly higher topography areas within the marsh. This reach is denoted as Wetland Swale A in Figure 1.1. A photograph of this drainage feature is shown in Figure 4.1.

The predominant function of this drainage route would be to convey overland flow during precipitation and runoff events toward the Magnetawan River. Given the meadow marsh type vegetation community within the area, it is evident that water or saturated soils are present at times throughout the year in sufficient duration to support this type of community. However, given that there is no defined channel to convey surface flows, this feature does not meet the definition of a waterbody in the REA Regulation. Therefore, no setback is required around this feature and no Environmental Impact Study (EIS) is necessary.

However, as noted in the Natural Heritage Site Investigation Report (Hatch Ltd., 2011b) the Wetland Swale A portion of this surface drainage feature does meet the definition of a wetland, since the community is dominated by wetland vegetation. Accordingly, as shown in Figure 1.1, the Project location does not encompass the portion of the feature identified as wetland.

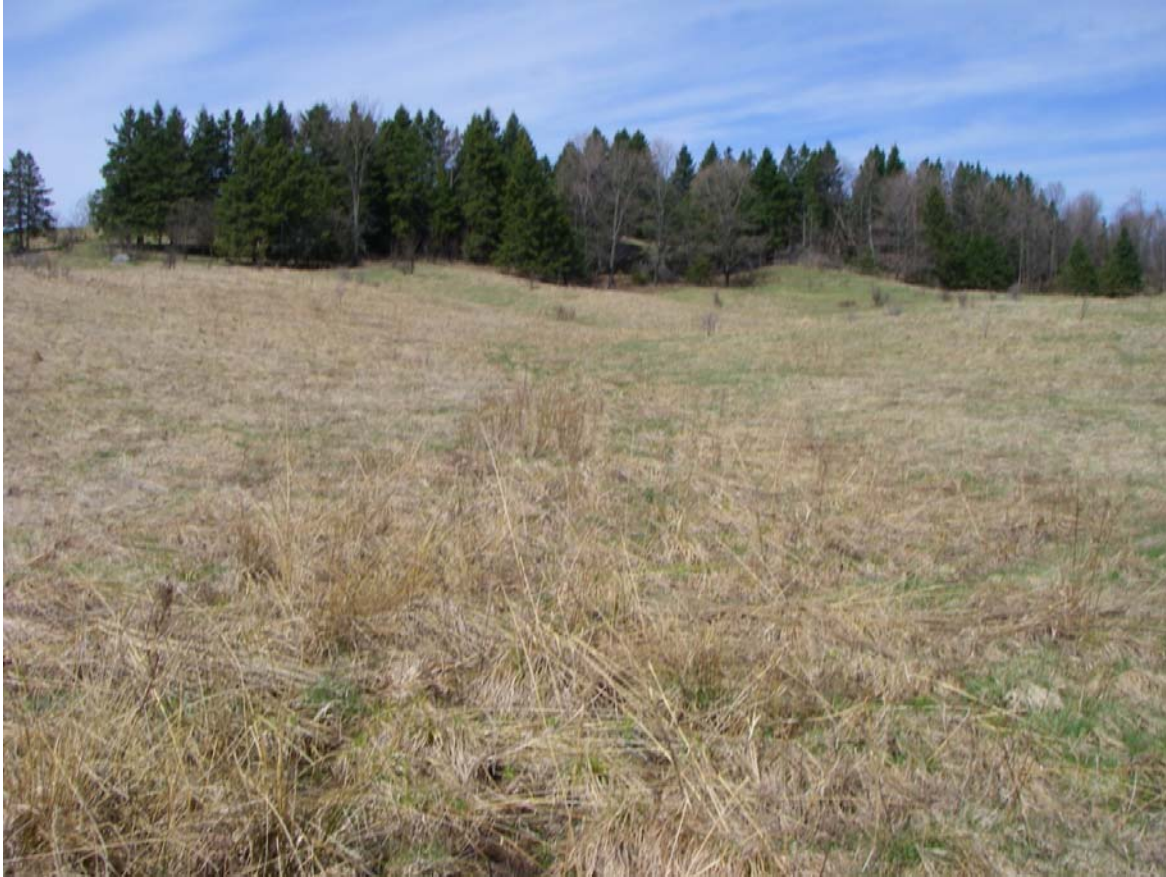
Figure 4.2 Photograph of Upstream End of Wetland Swale B

This feature was observed as originating in the southern portion of the property (noted as Wetland Swale B in Figure 1.1). It was determined that this feature is a temporary surface drainage route consisting of a low lying area between adjacent rolling topographical features. There is no defined channel and there was no flow observed during the site investigation noted in Section 3, nor during any of the other site investigations conducted to assess natural heritage features of the property (as discussed in Hatch Ltd., 2011b). The low-lying area predominantly consists of mineral meadow marsh vegetation, with sedges (primarily green, beaked, awl fruited and small fruited sedges) dominating the vegetation community. Horsetails, golden rods, and Canada blue-joint was also present although primarily on the peripheries or any slightly higher topography areas within the marsh. A photograph of this drainage feature is shown in Figure 4.2.

The predominant function of this drainage route would be to convey overland flow during precipitation and runoff events toward the wetland and the Magnetawan River. Given the meadow marsh type vegetation community within the area, it is evident that water or saturated soils are present at times throughout the year in sufficient duration to support this type of community. However, given that there is no defined channel to convey surface flows, this feature does not meet the definition of a water body in the REA Regulation. Therefore, no setback is required around this feature and no Environmental Impact Study (EIS) is necessary. However, as noted in the Natural Heritage Site Investigation Report (Hatch Ltd., 2011b) this surface drainage feature does meet the definition of a wetland, since the community is dominated by meadow marsh wetland vegetation. Accordingly, as shown in Figure 1.1, the Project location does not encompass the portion of the feature identified as wetland.

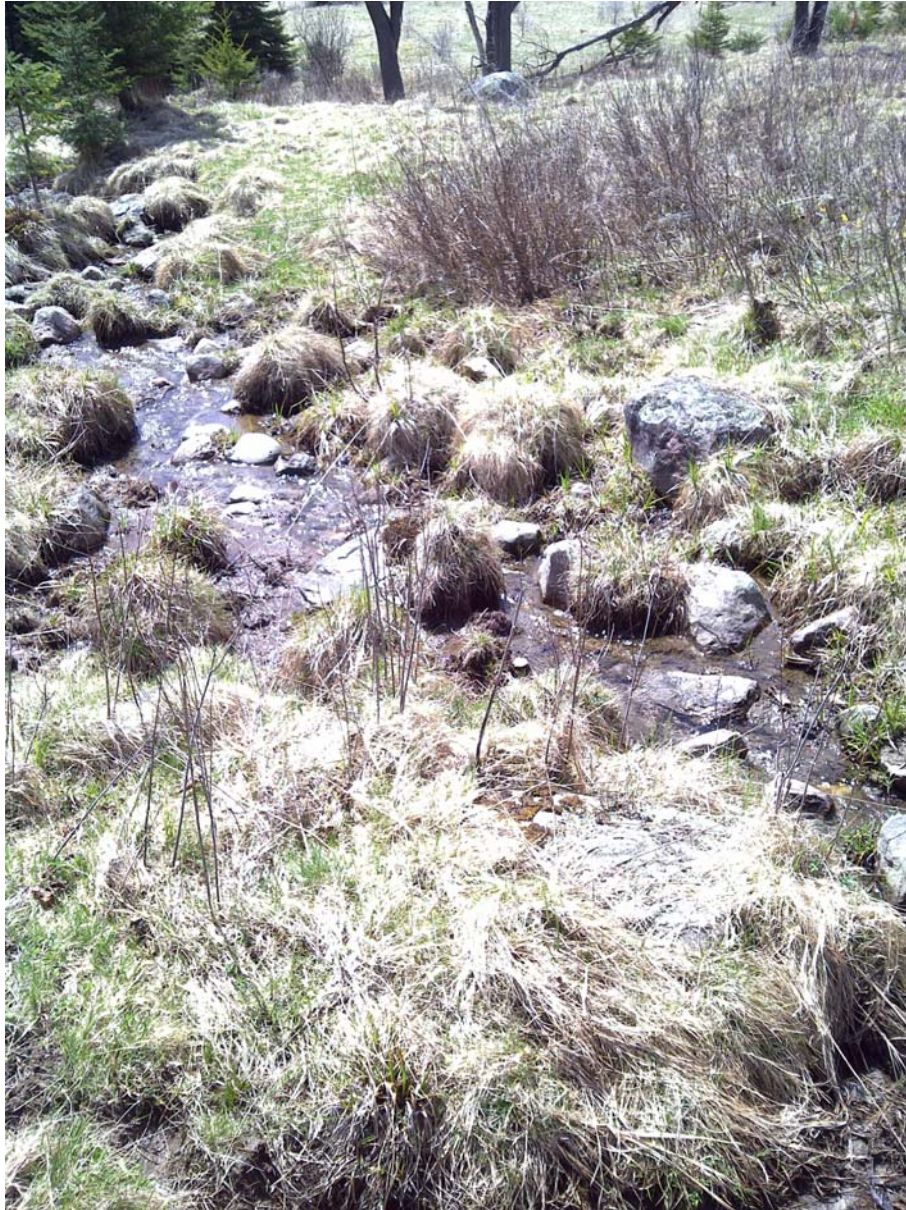
Figure 4.3 Photograph of Watercourse A

This watercourse was observed in the southwestern portion of the property. It consists of a defined watercourse channel originating from several seepage zones and flowing south toward the Magnetawan River. Flow from the seepage areas was present during the Site investigation and there was a defined channel with a variety of substrates including muck and rock (gravel and cobble). Wetland vegetation within and adjacent to the channel was predominantly meadow marsh

vegetation. This watercourse, the two seepage areas and the average annual high water mark are shown in Figure 1.1. A photograph of this watercourse is shown in Figure 4.3.

This watercourse meets the definition of a permanent or intermittent stream, since there is a defined channel present and there is no established vegetation community present within the channel. The average annual high water mark has been determined to be the top of bank of the channel. A 30-m setback has been applied, per the requirement of the REA Regulation. However, the project location is within 120 m of the average annual high water mark, therefore an EIS is required to consider to the potential adverse effects and mitigation requirements to protect this feature.
