Burk's Falls West Solar Project

Modification Document – Proposed Relocation of Stormwater Diversion Channel

H353720-00000-121-066-0001

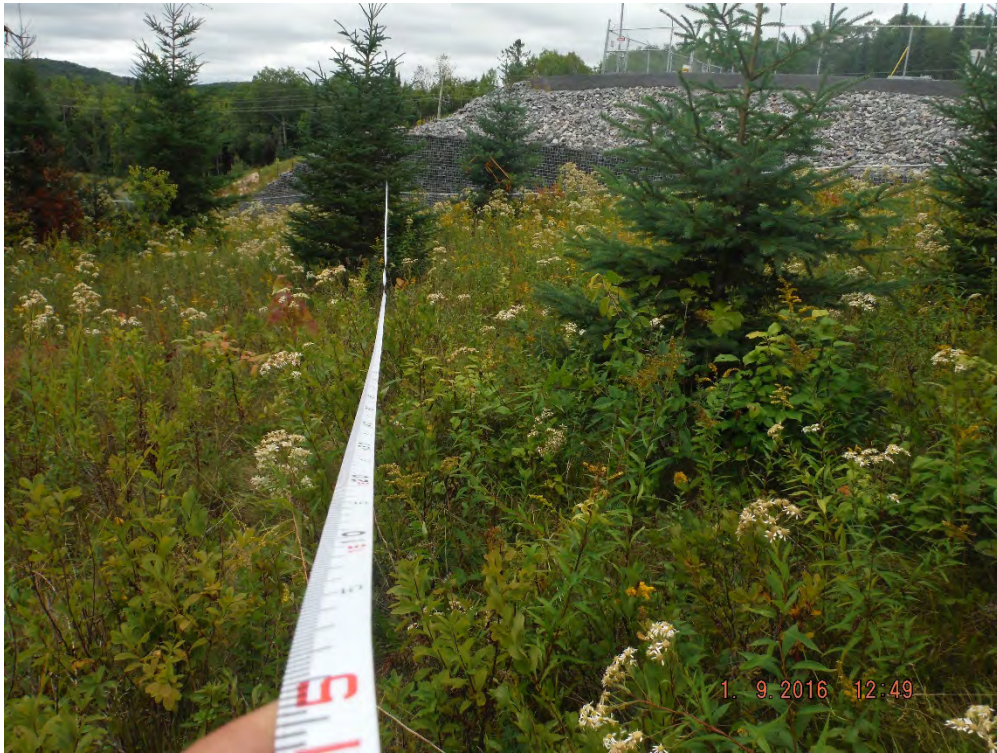
Figure 1 Looking Westward towards the Substation along Transect C

Northland representatives were on site September 1, 2016 and photographed the setback encroachment area for Hatch, to determine if Watercourse A (Figure 1-1) was still present and still within the same channel. Furthermore to confirm previous ecological land classifications identified in 2011.

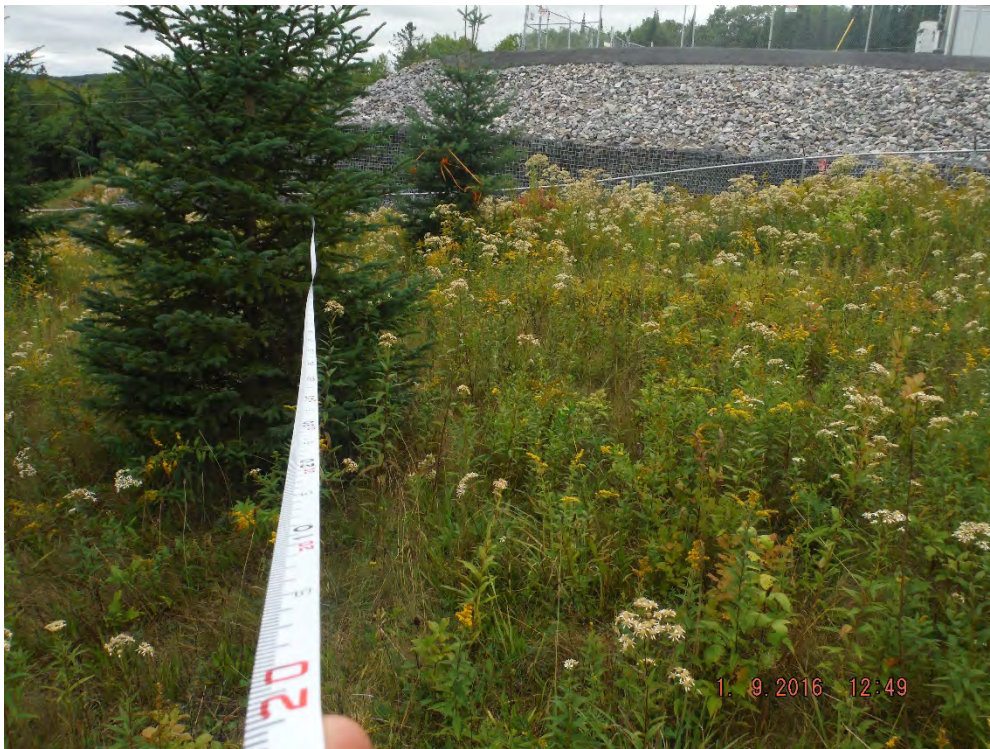
Figure 2 Looking Westward towards Substation along Transect C

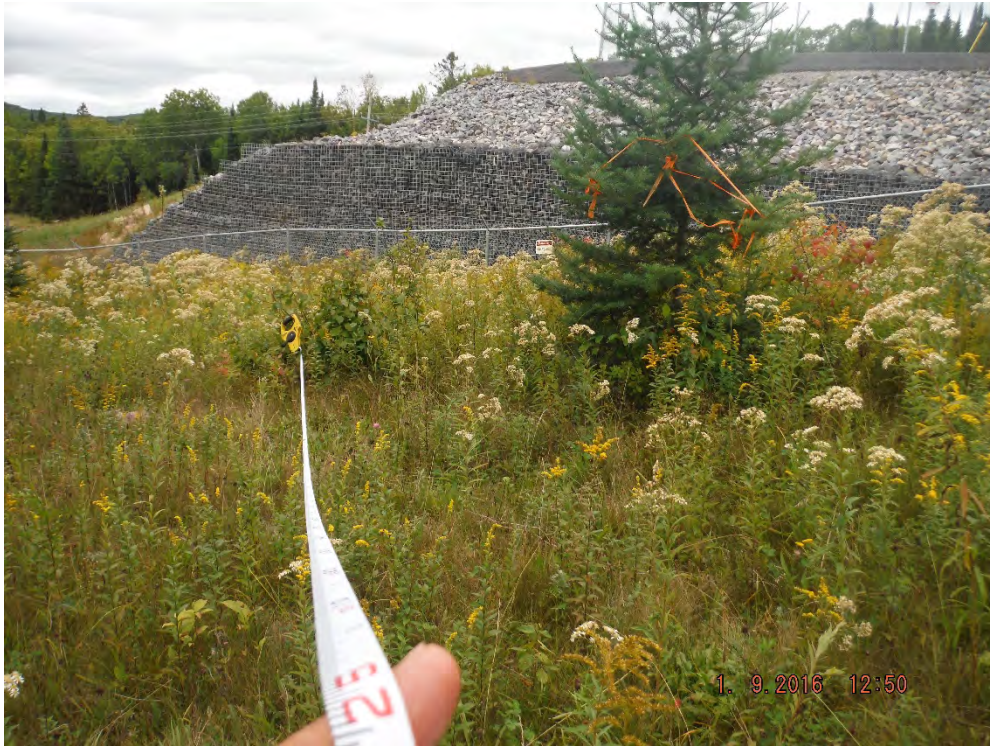
Figure 3 Looking Westward towards Substation along Transect C

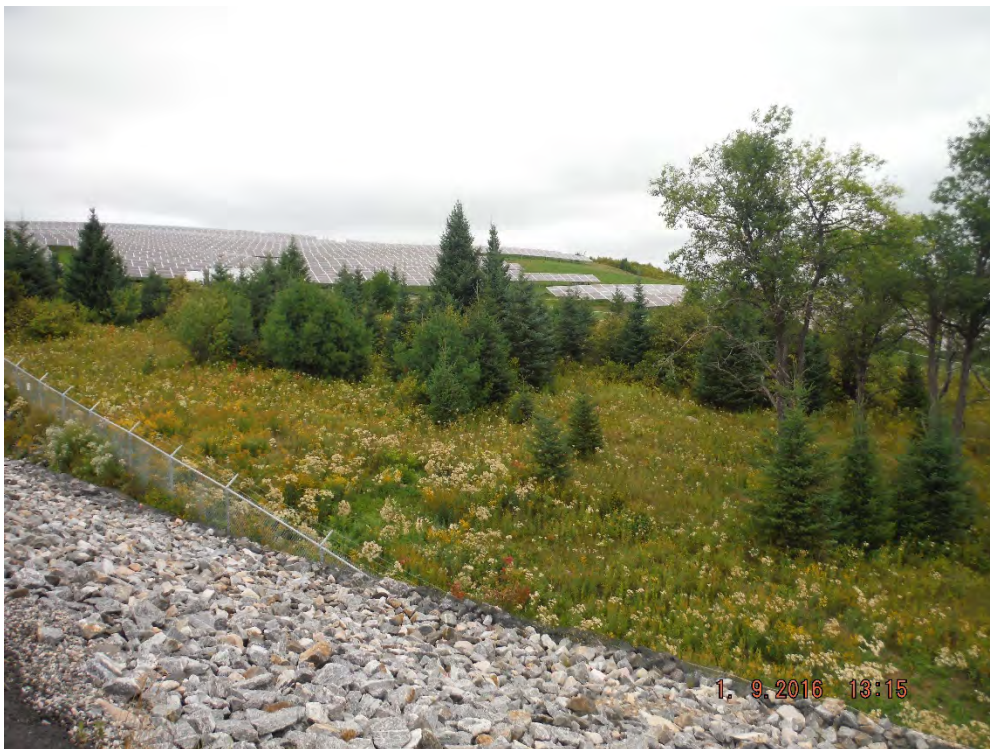
Figure 4 Looking Westward from Substation along Transect C

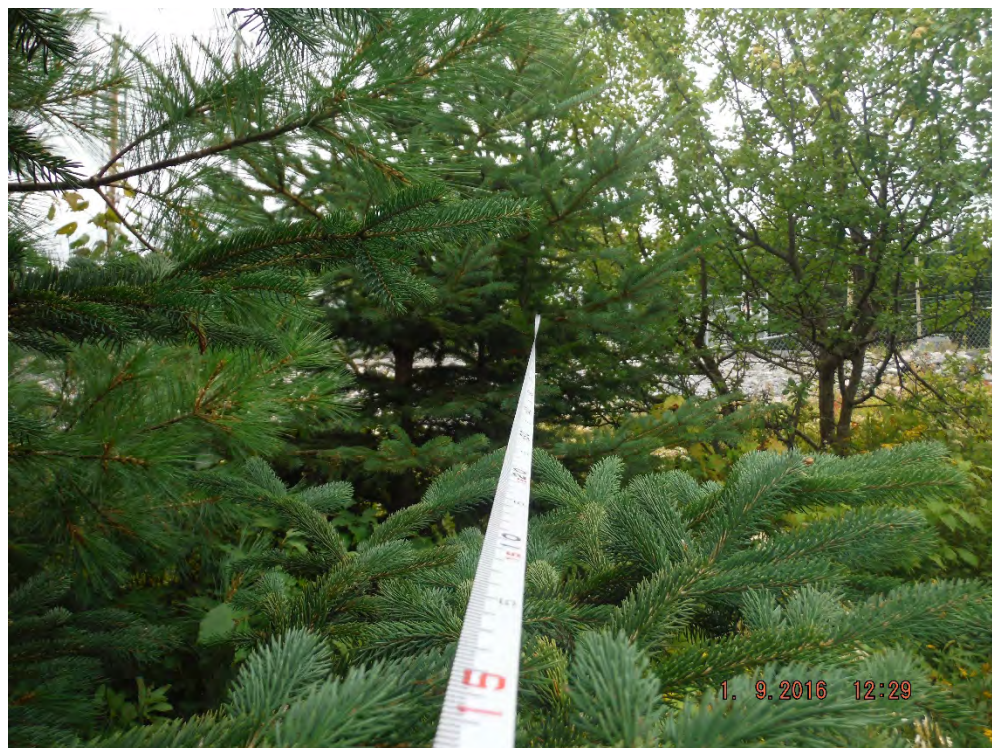
Figure 5 Looking Eastward towards Substation along Transect A

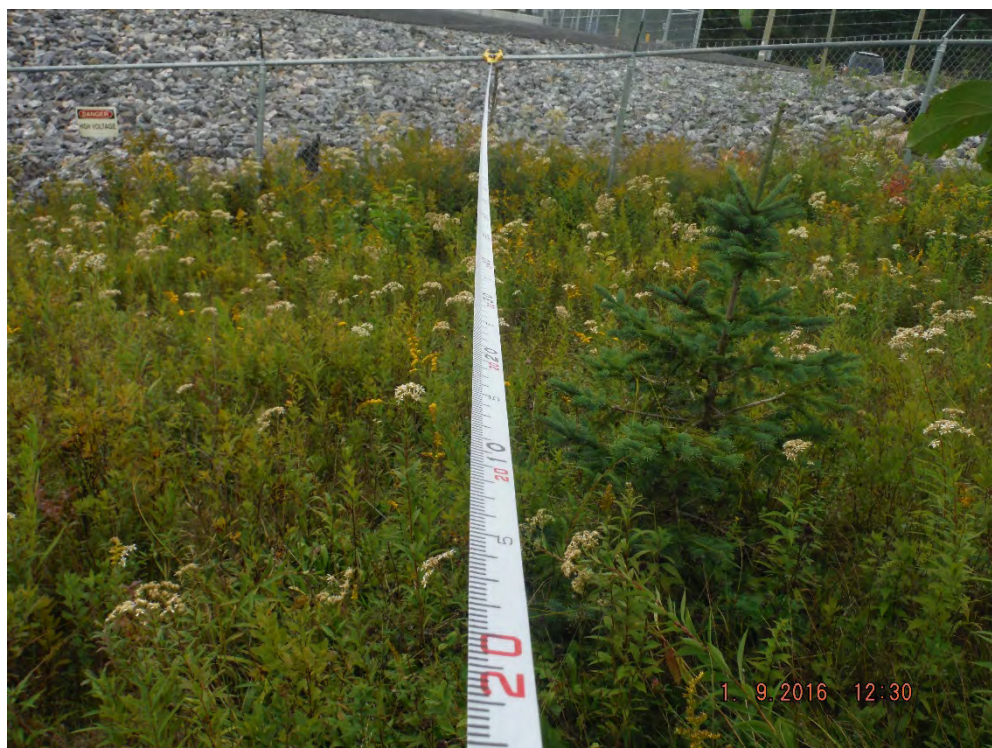
Figure 6 Looking Eastward Towards Substation Transect A

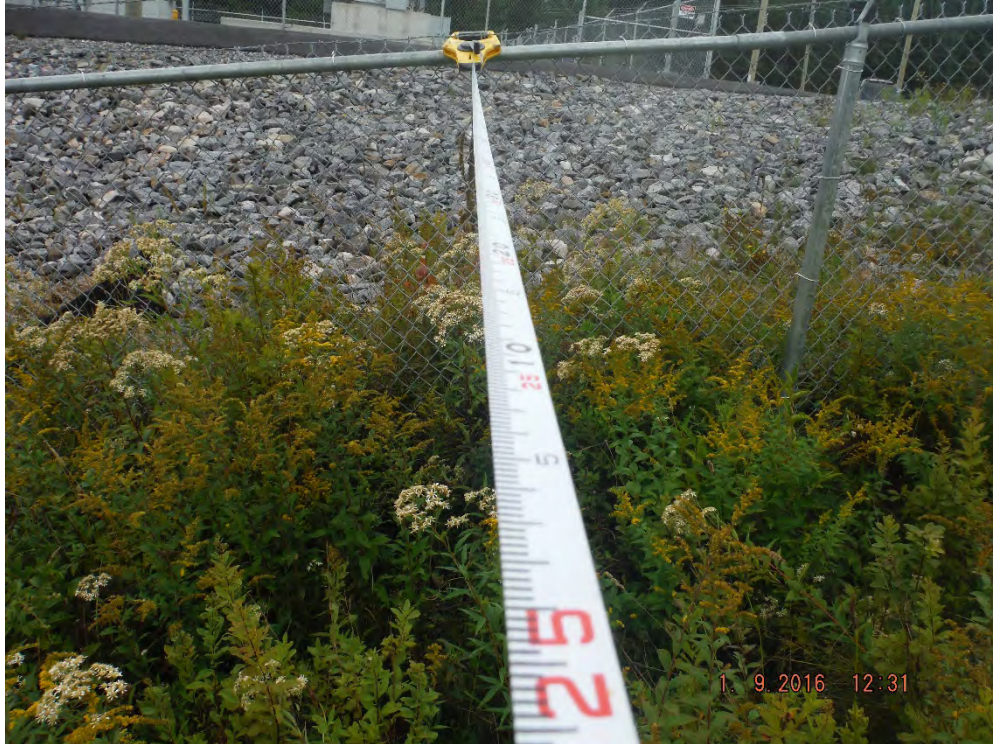
Figure 7 Looking Eastward towards Substation along Transect A

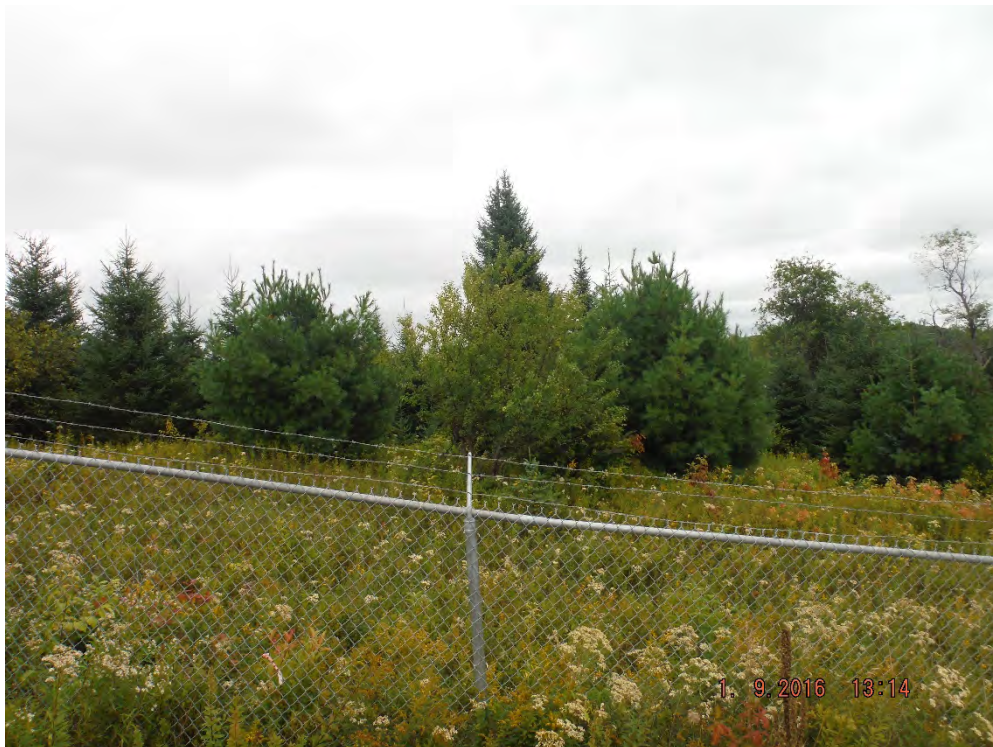
Figure 8 Looking Westwards from Substation along Transect

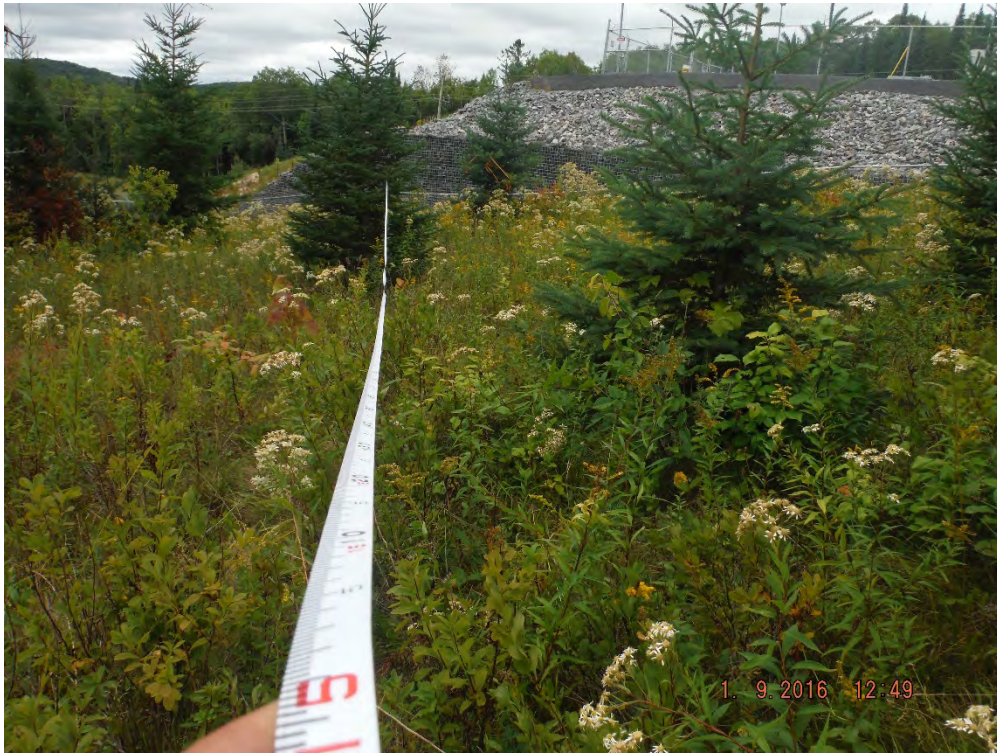
Figure 1 Looking Westward towards the Substation along Transect C

The stormwater diversion channel is described as a mixture of old field meadow and cultural thicket with rip/rap material associated with the existing substation base foundation fill along the western boundary. Photographs and measurements provided by Northland site representatives have confirmed the existing 30 m distance to the watercourse. Photographs provided in

Figure 1-1 and within Attachment 4 also confirm the Ecological Land Classification communities of Mineral Cultural Thicket and Dry-Moist Old Field Meadow (as identified in Figure 4-1) remain valid, although have progressed in succession.

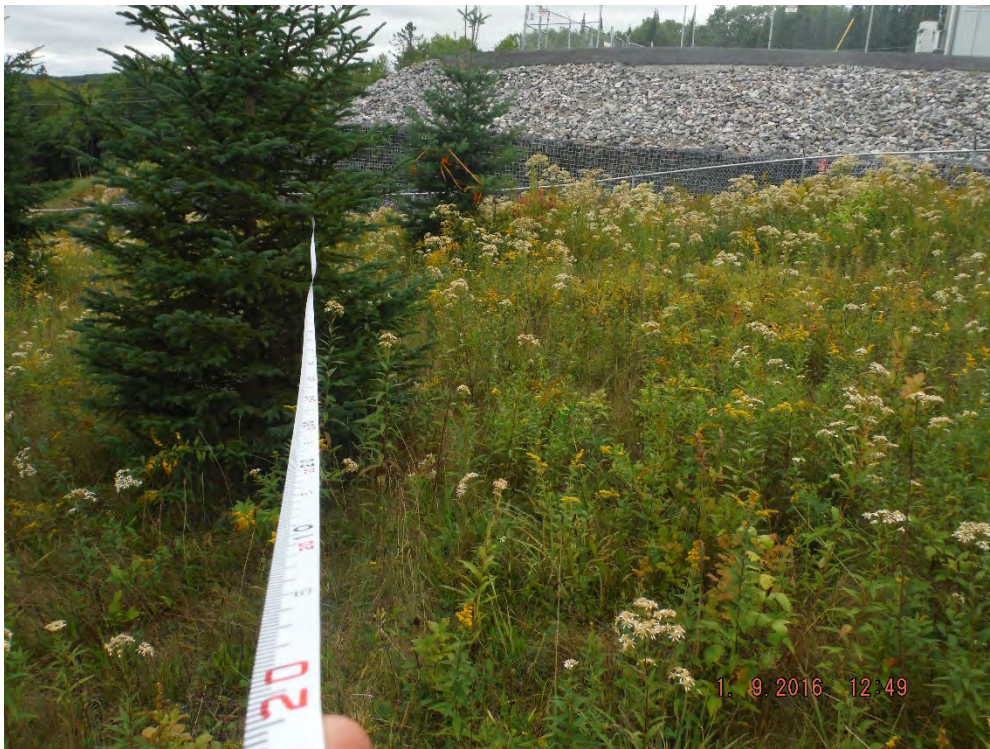
Figure 2 Looking Westward towards Substation along Transect C

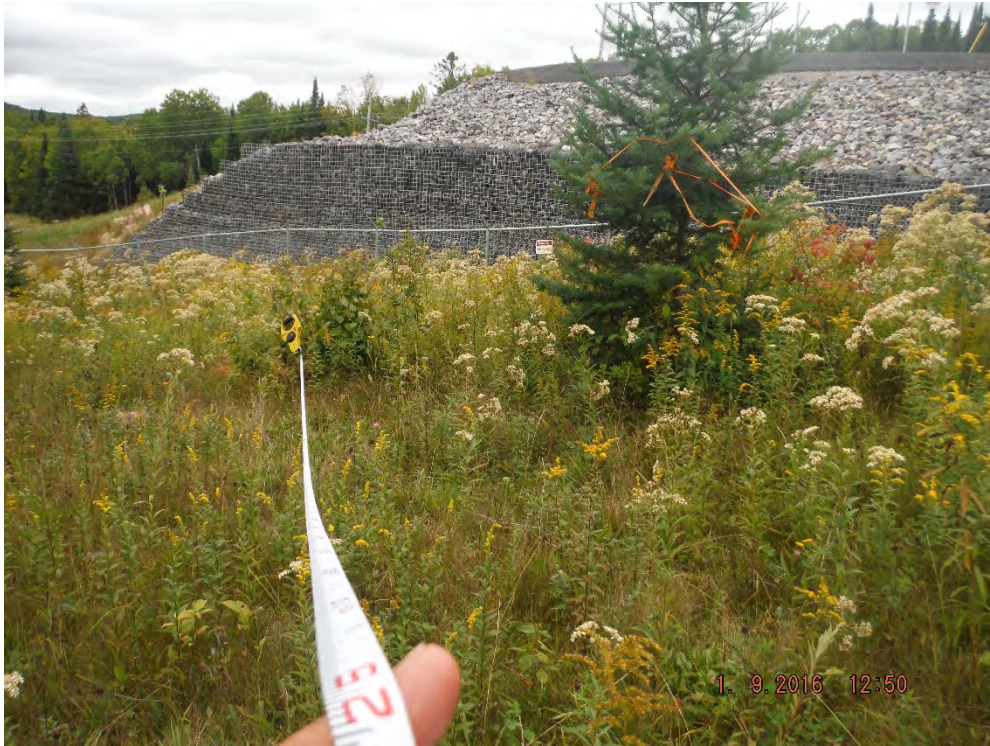
Figure 3 Looking Westward towards Substation along Transect C

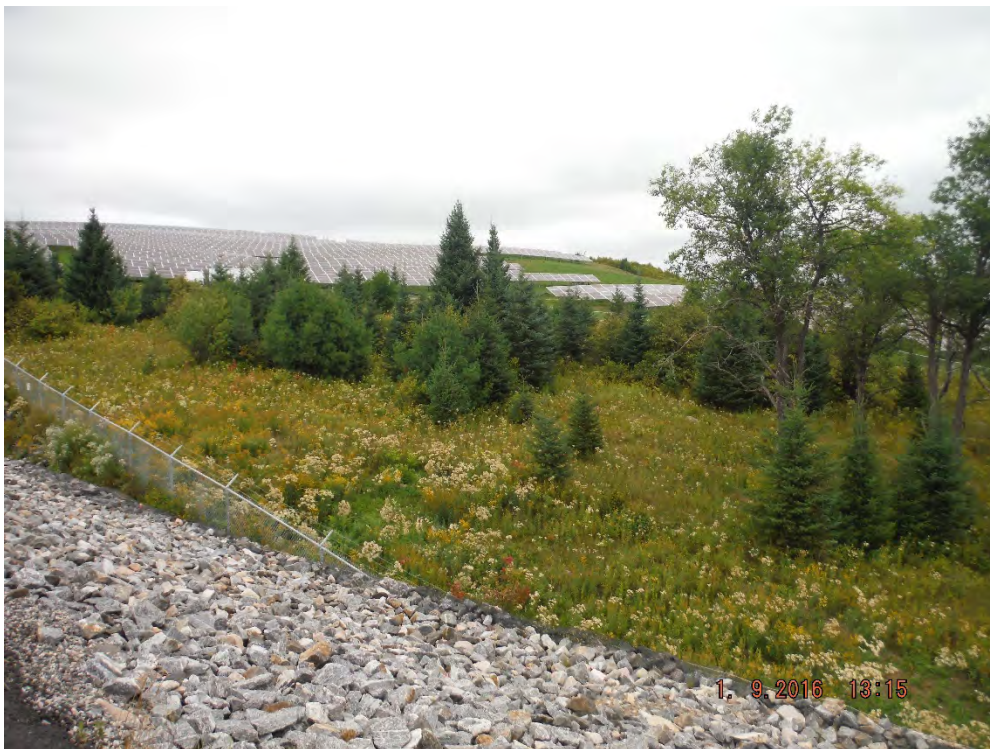
Figure 4 Looking Westward from Substation along Transect C

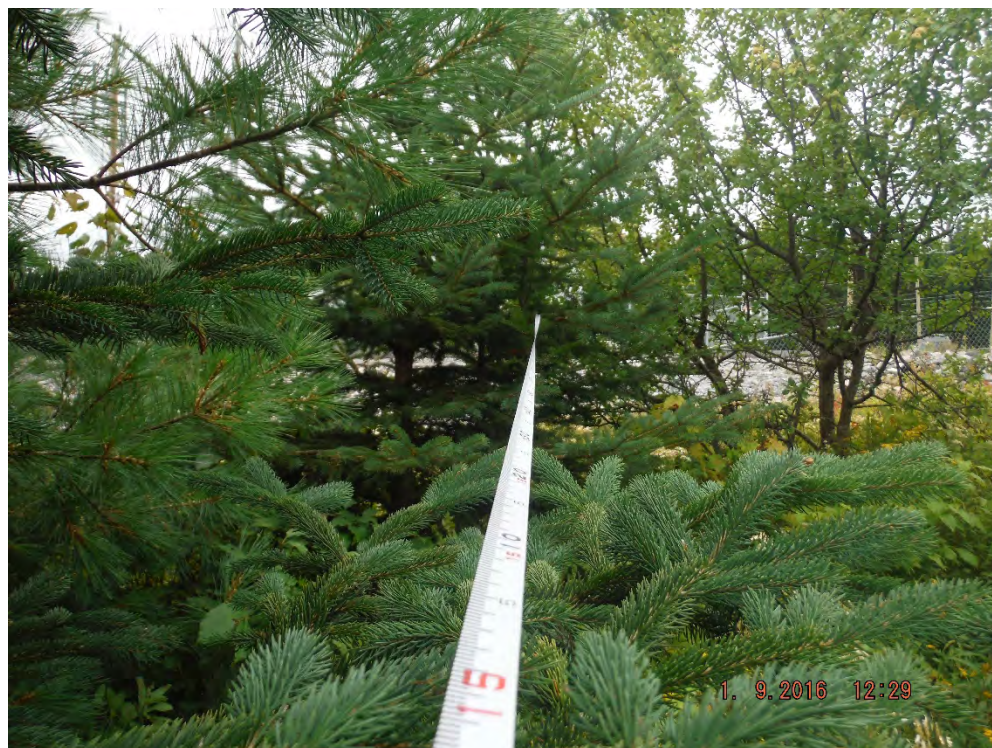
Figure 5 Looking Eastward towards Substation along Transect A

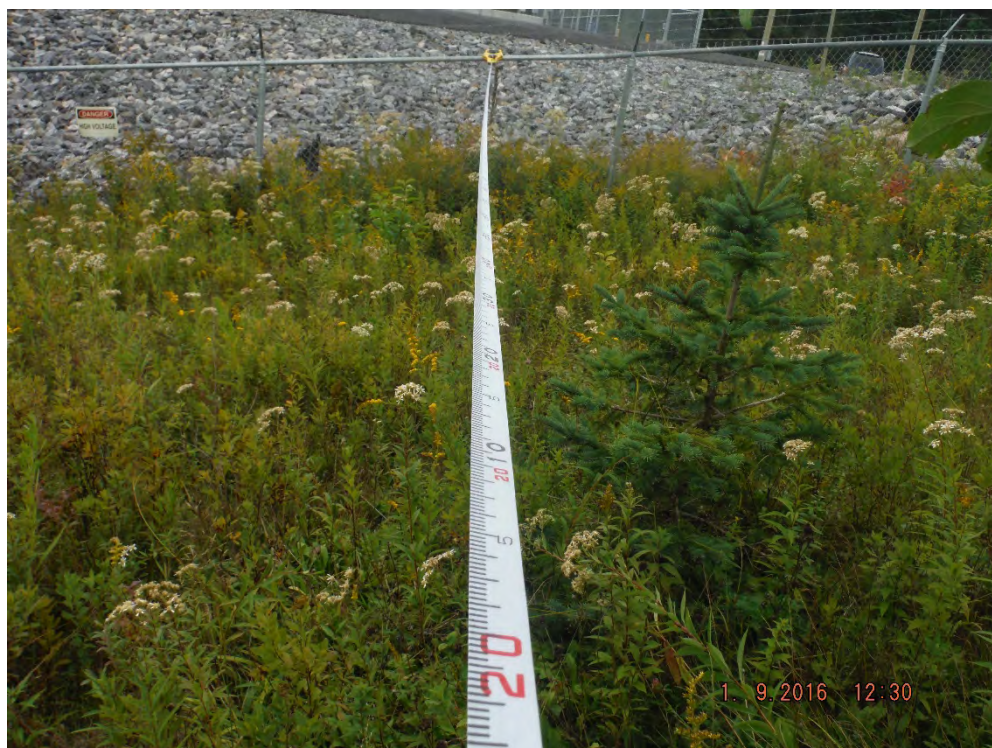
Figure 6 Looking Eastward Towards Substation Transect A

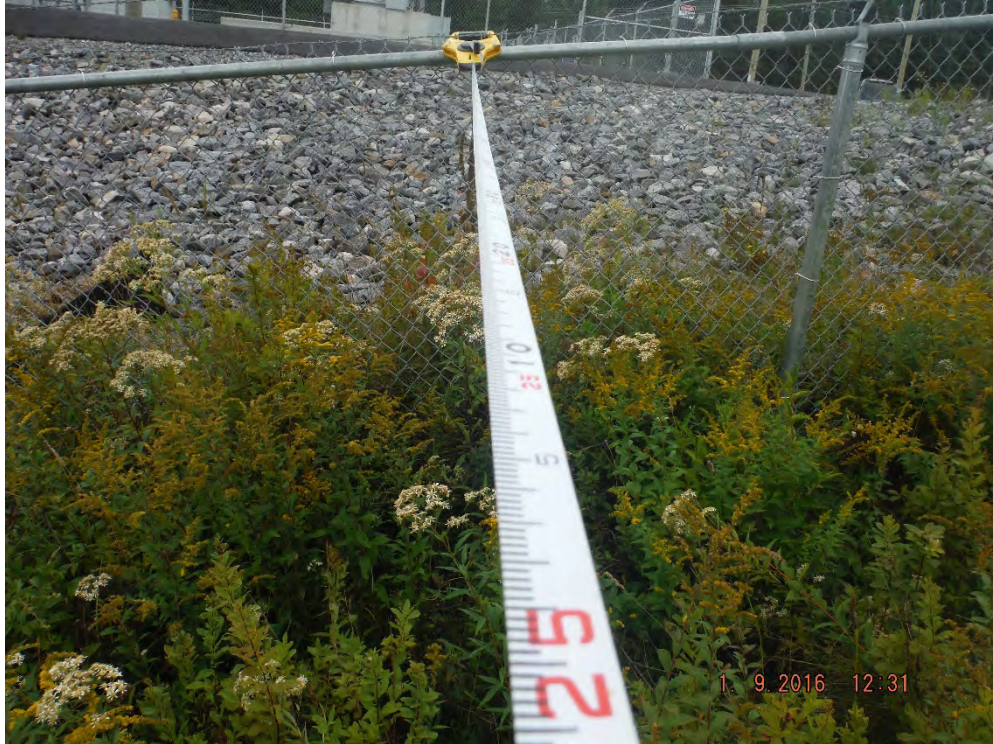
Figure 7 Looking Eastward towards Substation along Transect A

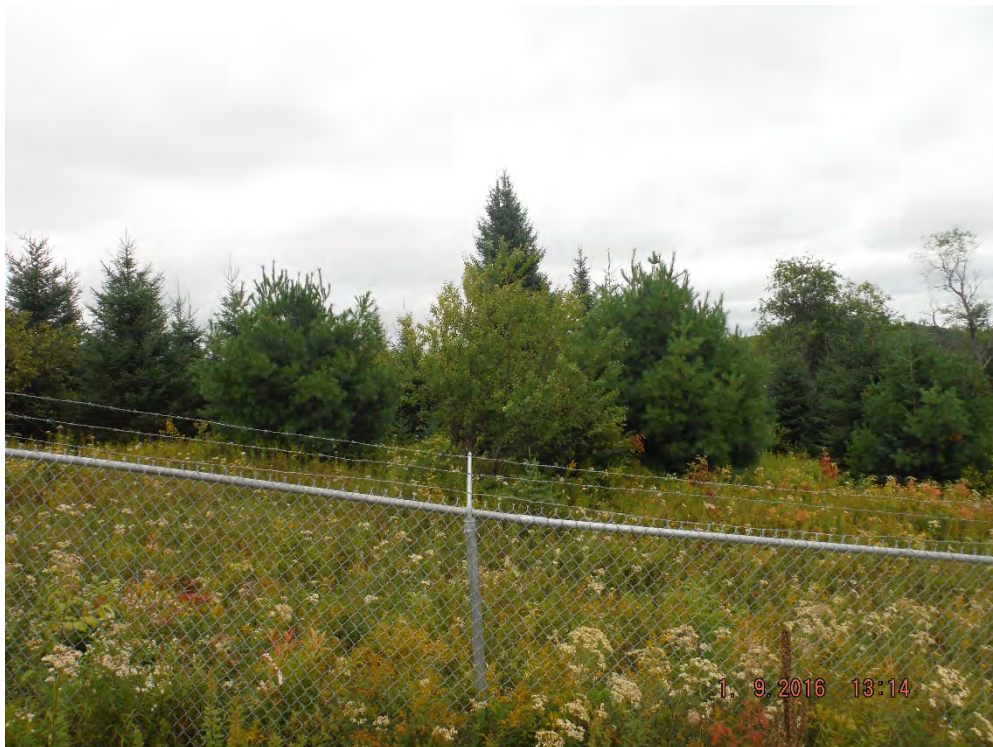
Figure 8 Looking Westwards from Substation along Transect
