Appendix B
Correspondence

Grand Bend Wind Farm Ministry of Natural Resources Project Status Meeting

File No.: PIA019991

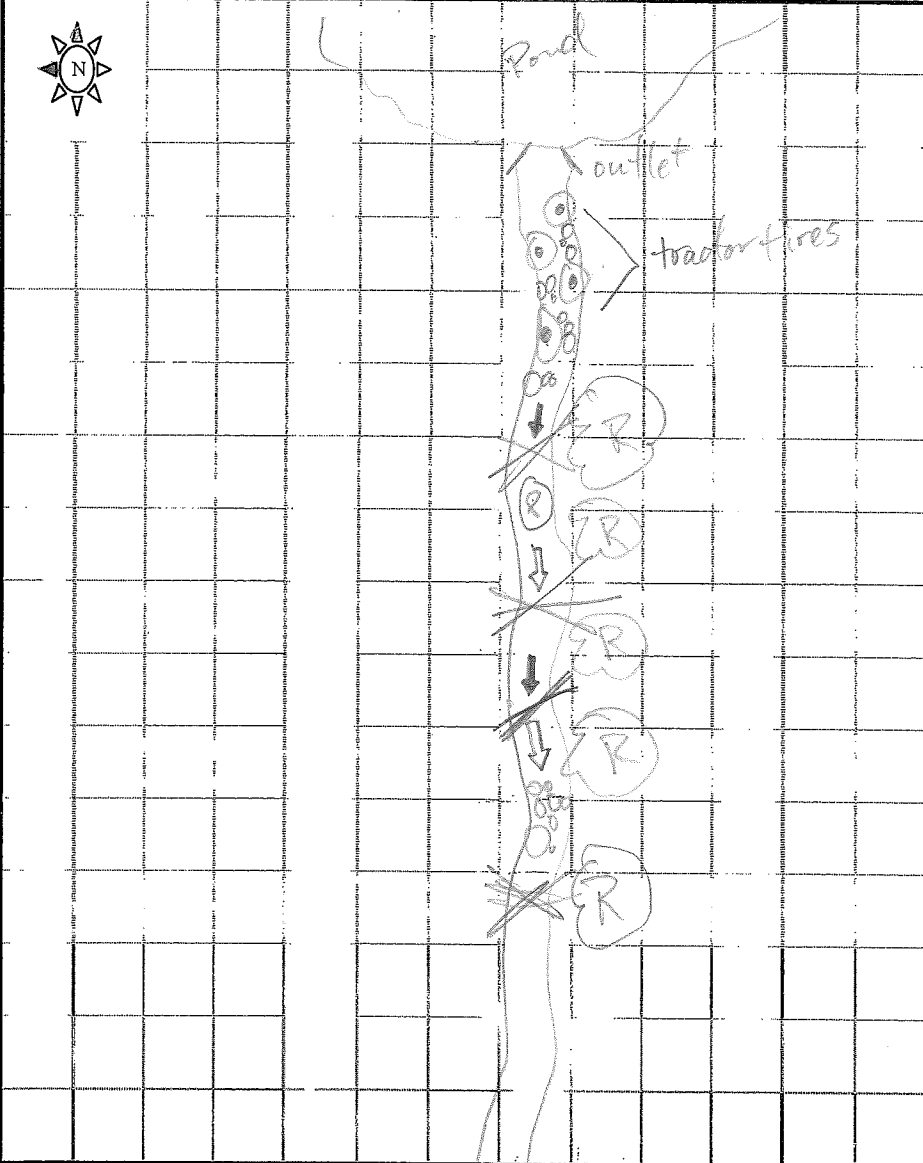
PROJECT #: PIA00991	
		MAPPER: CP	
		NAME OF WATERBODY: Charette Drain	
		CROSSING #: CR-026	
		STATION #:	
		DATE: DD-MMM-YY 20-03-12	
		LEGEND 10d depth (cm) 6w width → Riffle ⇨ Run/Glide ○ Pool ▨ Island/Bar ▨ Fine Substrate ### Gravel Substrate oOooO Cobble /Boulder *** Debris CT Cattail SV/FV Submerg/Float Veg EV Emergent Vegetation W Watercress Fe Iron Staining // // // // // Eroded Bank xxx Riprap / Other Stabilization ○ Instream Log/Tree ^^^ Dam/Weir/Obstruction ® Riparian Tree ▶ Seep/Spring - - - - Undercut Bank — Barrier to Fish Movement -S- Seasonal Barrier -x-x- Fence line ┌ └ Culvert	
PROFILE:	Horz. Scale	Vert. Scale

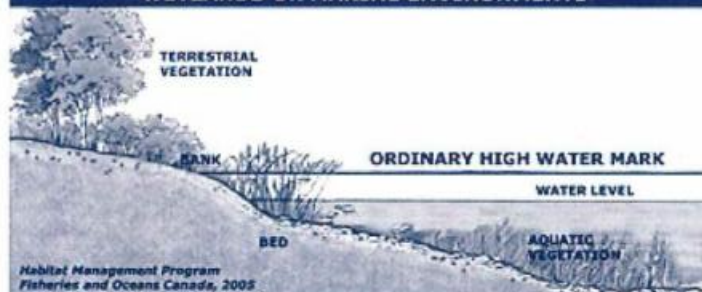
**CROSS-SECTION OF INLAND LAKES,
WETLANDS OR MARINE ENVIRONMENTS**

For the Great Lakes this refers to the 80th percentile elevation above chart datum as described in DFO's Fish Habitat and Determining the High Water Mark on Lakes.
